GENERAL BUILDING INSPECTION REPORT FOR
1111 11th Avenue, Seattle, Wa.
FOR THE EXCLUSIVE USE OF New Construction

May 2, 2000

cover letter, 24 page report

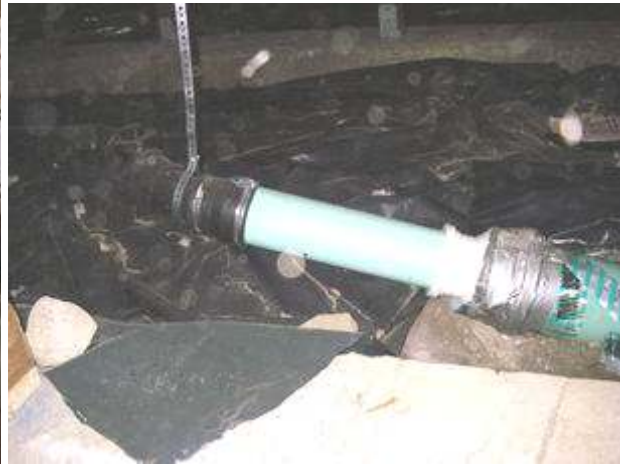
1 **Under the vapor barrier, the sewer line has been improperly spliced with no hub**
2 **fittings and it appears the leak-proof integrity depends on duct tape.**
3

6
7 *“spliced” sewer pipe*

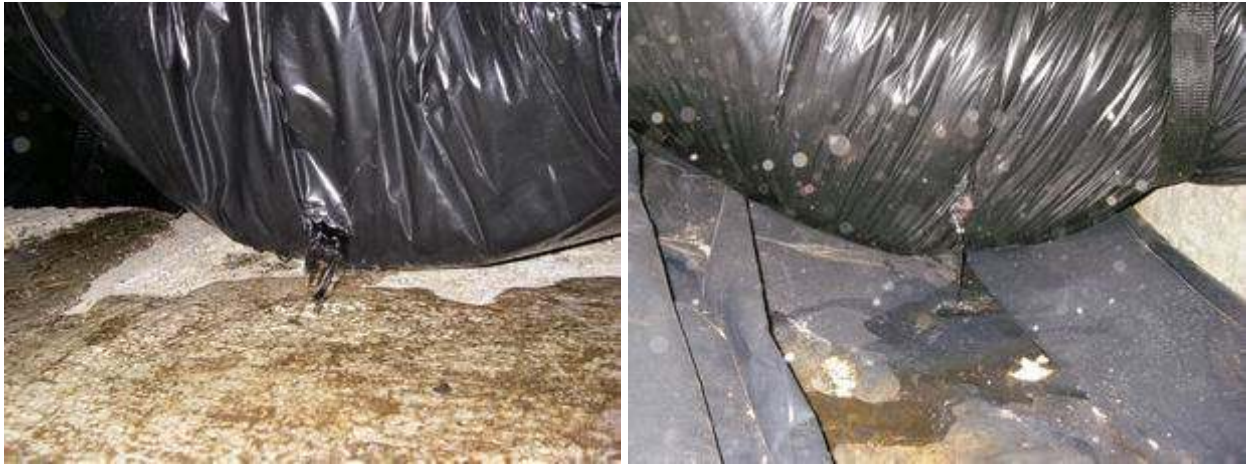
2
3 *heat ducts blocked by accumulated water*

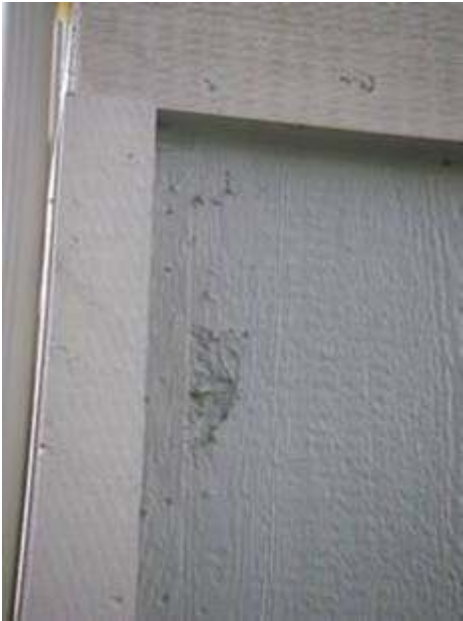
damaged siding skin

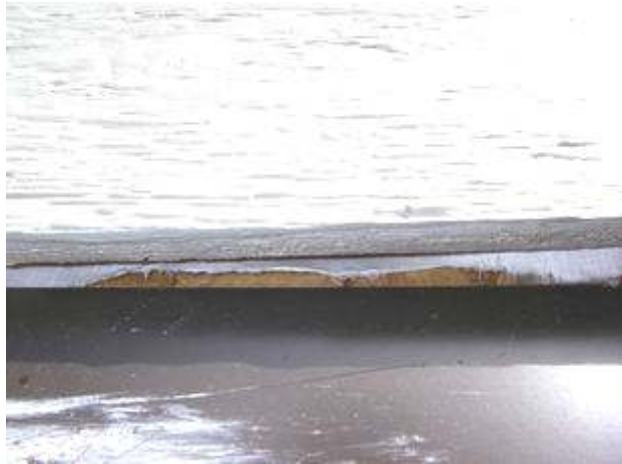
5
6 **Of equal concern is that at the front of the dormer, the siding does not come down**
7 **far enough and has left the sheathing exposed, and the requisite vapor barrier (paper or**
8 **wrap) is not visible. It is somewhat worrisome that at the only area visible that should**
9 **reveal paper, none exists.**

exposed sheathing above roof-to-wall flashing

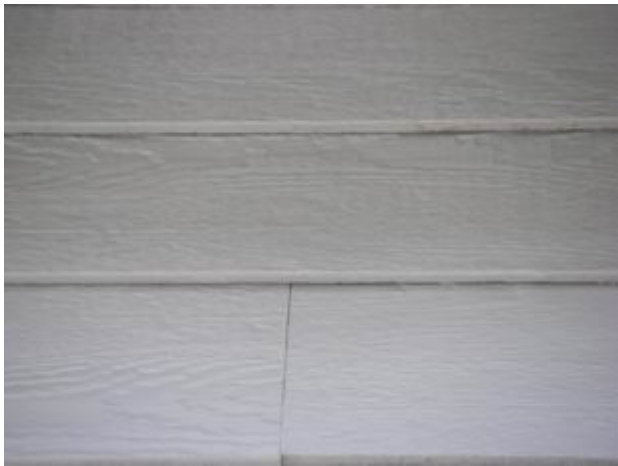
butt joint uneven & not caulked

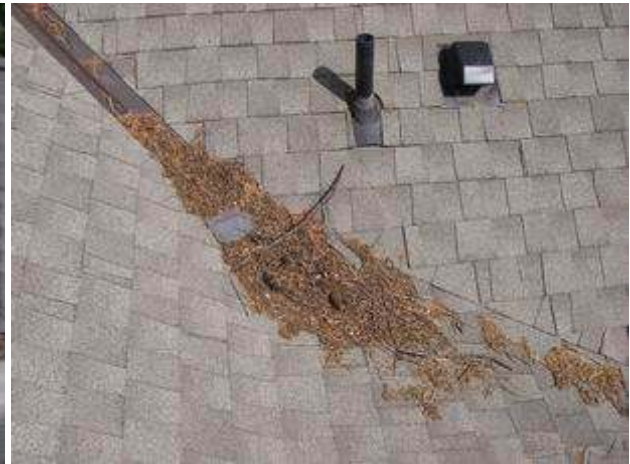
1 The roof consists of one tier of laminated architectural-style asphalt/fiberglass composition
2 shingles. No significant defects were noted in the roofing material or valley or vertical plane
3 flashing. **A considerable amount of construction debris has been left on the roof; the debris**
4 **should be picked off the roof and out of the gutters to prevent it from entering the**
5 **downspouts and drain lines. Any cellulose debris accumulation should also be removed from**
6 **the roof surfaces and gutters.**
7

organic and construction debris

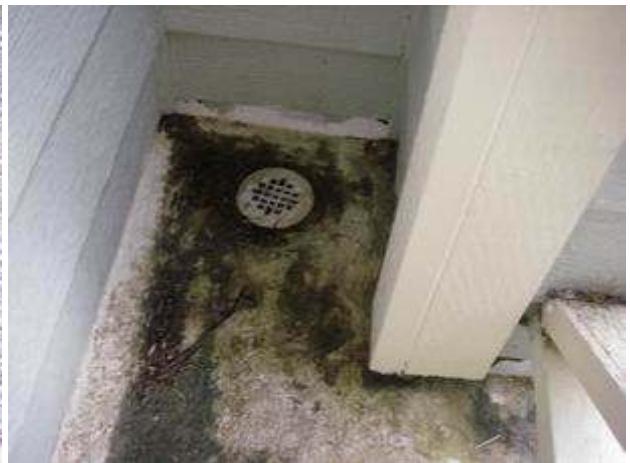
drain grate over entry (see below)

1 Due to what appears to be a sprayed-on finish, the type of roofing over the entry
2 could not be determined. The grate for the drainage scupper is resting on the surface, so
3 ponded water will accumulate on this surface. A conversation with the builder on this point
4 is recommended.
5
6

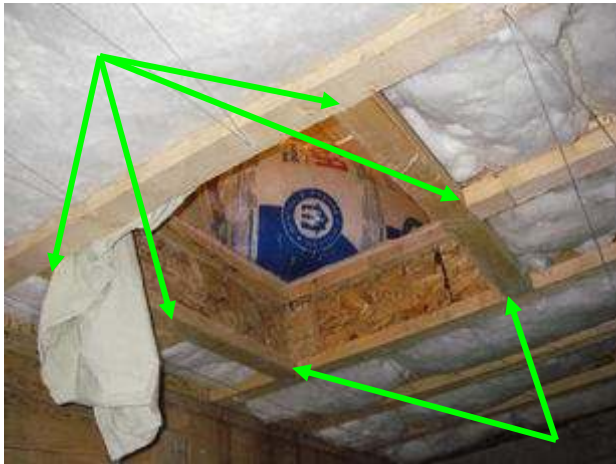
9 The crawl space is accessed via a pass-through in the understair closet. No significant
10 defects were observed in the concrete perimeter footings, strip footings, or foundation walls. The
11 foundation framing consists of 9½-inch Louisiana Pacific thin-web floor joist 16 inches on center
12 mounted on 4x10 beams supported in turn by 4x4 posts. The header installed at the access and
13 carrying one joist has been improperly nailed into place. Nailing through the chords is
14 prohibited; hangers should have been used (as they were at the fireplace bump-out). The
15 top chord of another joist has been notched for plumbing clearances, another prohibited
16 modification. All manufactured joist companies dictate that their products not be modified
17 in either of these ways and if they are, that the manufacturer must be contacted to design the
18 appropriate repair to keep the warrant in force.
19

20 *joist hangers & nailers required at these points*

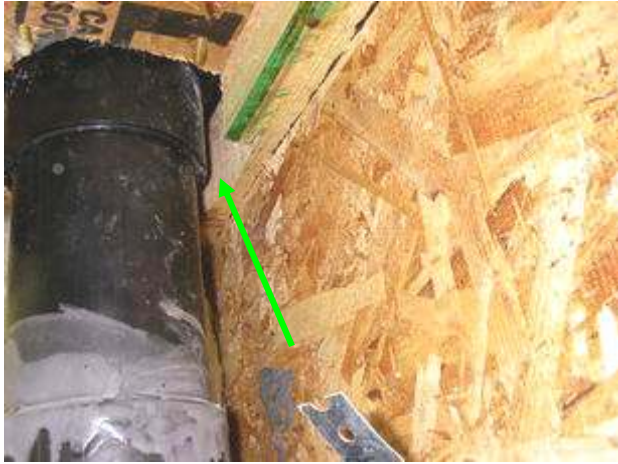
2 *notched top chord*
