GENERAL BUILDING INSPECTION REPORT FOR
22716 Second Court of Last Resort, Spendy Suburb, Wa.
FOR THE EXCLUSIVE USE OF Savvy and Prudent Byers

Antiquarius 3, 2008

1 **OVERVIEW**

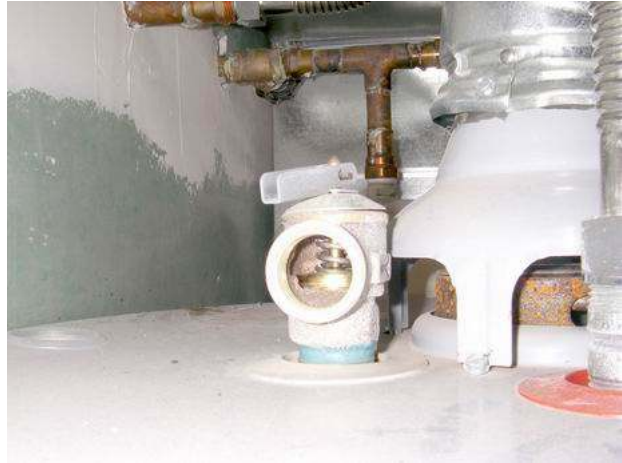
27
28 The water heater is equipped with a temperature/pressure relief (TPR) valve. The
29 temperature/pressure relief valve is set to open at either 150 psi or 210 degrees F. **There is no**
30 **discharge pipe installed at the pressure relief valve; discharge piping is required and should**
31 **discharge to the exterior of the house.** Earthquake restraining straps are in place. Observation
32 through the viewing port revealed a strong blue flame which is a sign of proper burning. Using the
33 TIF 8800 combustible gas detector, the gas supply lines were checked for natural gas leaks and
34 none were found. The ignition source is properly located a minimum of 18 inches above the
35 garage slab floor. No backdrafting or spillage was detected at the flue and no significant moisture
36 or corrosion was noted at the bottom of the water heater tank. **The exhaust flue for this**
37 **appliance has a significant reverse slope at two different places; gas flues must have 1/4-inch**

no discharge pipe from TPR valve

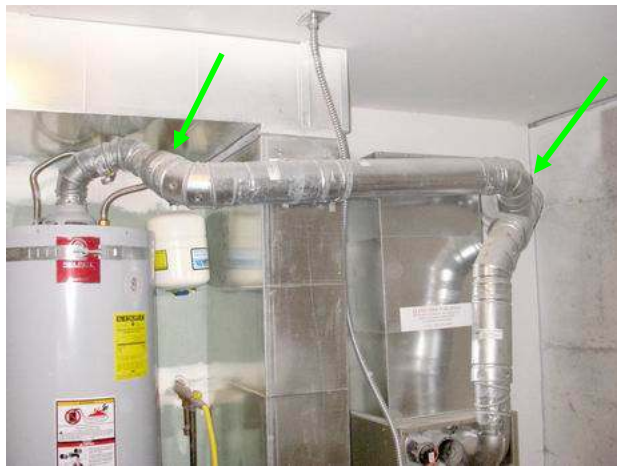
reverse slope (twice) in water heater flue

38 **per foot upward slope away from the appliance.** **A written dialogue with the local permitting**
39 **authority on this point is recommended.**

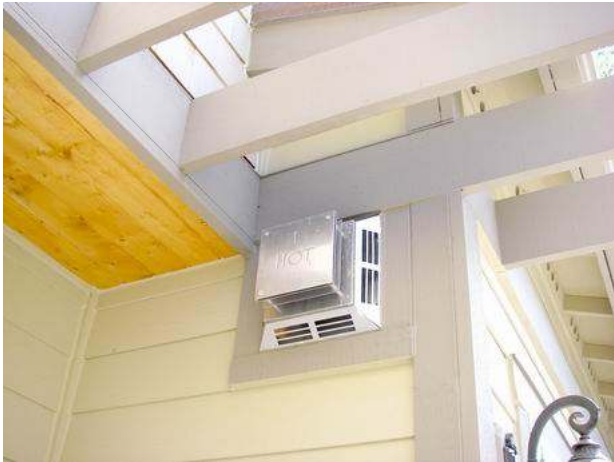
16 *fireplace flue in close proximity to framing*

22 **There is some concern over the clearances of the fireplace flue to the adjacent exterior**
23 **framing. Because our queries have not yet been responded to, the manufacturer's**
24 **installation instructions should be reviewed to confirm that the close proximity of the flue to**
25 **the framing is an approved installation.**

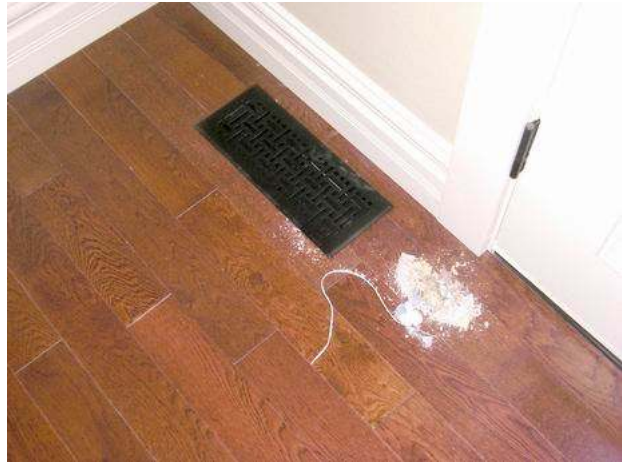
10 As is typical when a furnace is not located in the center of the home, the heat flow is
11 diminished at the registers furthest from the furnace. This can often be compensated for by
12 balancing the registers. **As a considerable amount of building debris and dust accumulates
13 in the heating system during construction, having the furnace and heating ducts
14 professionally vacuumed is recommended.**
15

17 *debris from register boot*

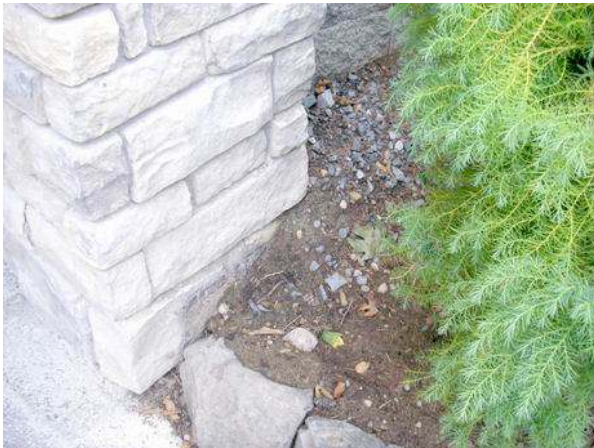
2
3 **The earth or groundcover is in contact with or in close proximity to the cultured stone**
4 **vener walls at the southwest corner.** The cultured stone covers the wood sheathing and
5 **framing and is not water proof, so it should be treated like any other siding: the soil or**
6 **groundcover should be kept four to six inches below the top of the concrete foundation wall.**
7 A four to six inch clearance should always be maintained between any earth, groundcover or
8 foliage and any siding or wood members of the house. This aids in eliminating an attraction for
9 wood boring insects or organisms. **The earth or groundcover should be excavated away from**
10 **the siding and/or rock veneer walls and the soil sloped to drain away from the foundation.**

28 *soil against cultured stone veneer*

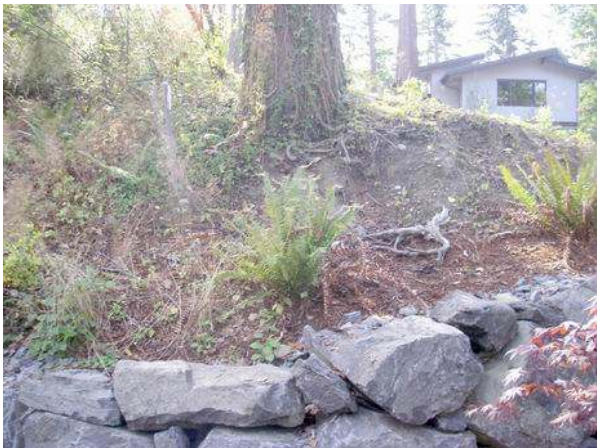
22
23 **There are multiple areas where cuts have been made to the slope on the south side of**
24 **the home, which may create a stability issue for the trees at the top of the slope. The client**
25 **may want to consult with a geotech and/or arborist to confirm that support for the trees is**
26 **adequate.**

29 *roots for this tree may have been cut*

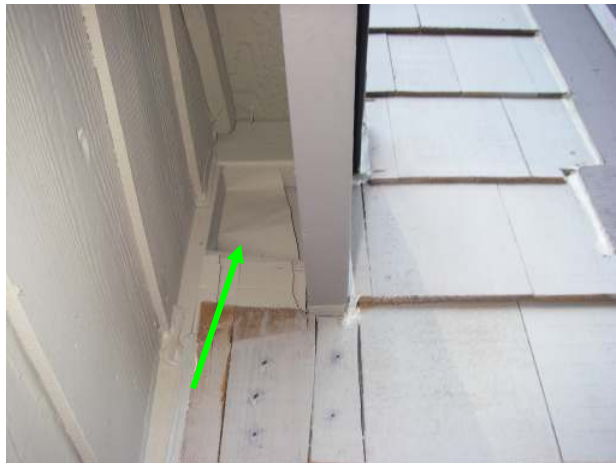
2
3 This home is clad with a cementitious lap siding, cultured stone veneer, and cedar shingles.
4 No significant defects were noted in the stone or the cementitious composition lap siding. The lap
5 siding appears to be a Hardiplank product, advertised as a 50-year fiber-cement product that is
6 immune to permanent water damage and termites. It has, however, been known to absorb water
7 and swell, giving it a wavy appearance. **The cedar shingle siding warrants attention. The**
8 **transition details are incomplete in some small difficult-to-see areas where moisture intrusion**
9 **in a swirling wind-driven rain must be regarded as likely. In addition at least one shingle**
10 **panel has not been properly nailed; the center of the panel can be depress ½ inch. Blind**
11 **nailing was also not used in all areas. The soffit was omitted from the fireplace bump-out,**
12 **leaving the framing and (hopefully-soon-to-be-in-place) insulation unprotected.**

14 *exposed building paper, not weathertight*

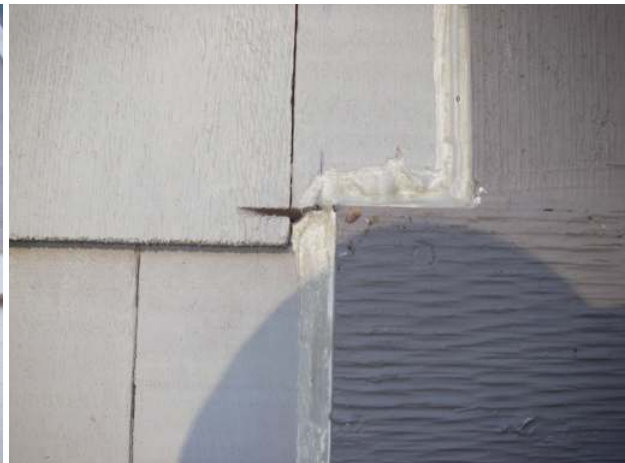
15 *overcut and uncaulked shingle at window*

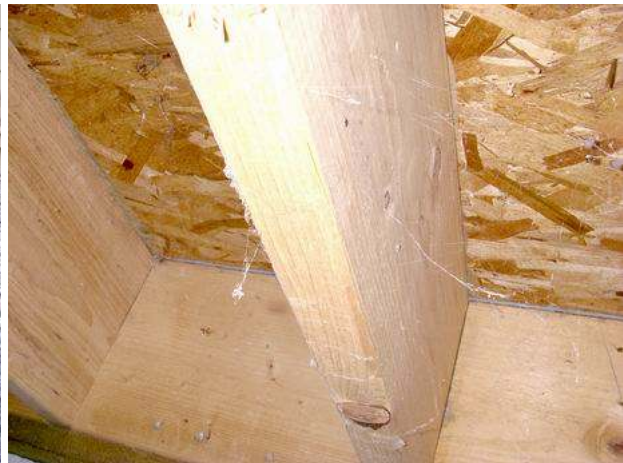
18 *exposed framing underneath*

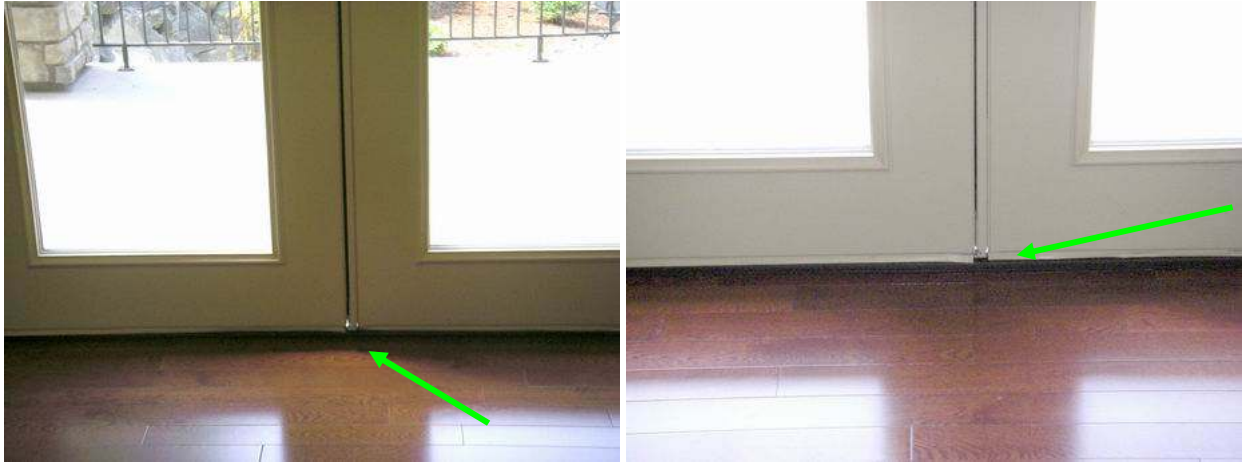
1 **None of the double French-type doors are weather-tight; this is especially critical on**
2 **the weather side of the home. Moisture intrusion at these points will not only promote decay**
3 **but ruin interior finishes (e.g., hardwood floors). The building contractor should take the**
4 **necessary steps to provide assurances that the exterior shell was built to a weather-tight**
5 **condition.** The door and window sills are in serviceable condition. The exterior hose bibs are
6 functional and securely mounted to the home. The eave areas are in serviceable condition with
7 numerous vents to the attic.

9
10 *doors not weather-tight*

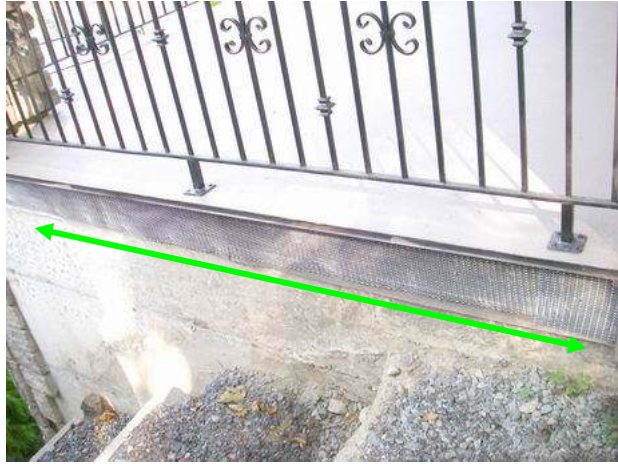
11
12 The deck framing is not accessible to inspection due to the soffit underneath and is
13 exempted from the scope of this inspection. The deck coating appears to be a fluid-applied
14 elastomeric coating. Requesting information regarding manufacturer brand, recommended
15 maintenance, and warranty documents is advised. Most manufacturers prohibit the use of
16 some types of furniture that may damage the deck surface. Because all penetrations of the
17 deck surface can lead to water damage, requesting information on the method of sealing the
18 handrail bolts is also recommended. *The downspout also constitutes a penetration and the*
19 *differing thermal expansion and contraction characteristics of the membrane and the*
20 *downspout metal could cause a separation of the membrane; a written dialogue with the builder*
21 *on this point is recommended.* **The south edge of the deck appears to be unfinished;** the mesh

22 fastened to this area may indicate that cultured stone was to be installed.

unfinished mesh on side of deck

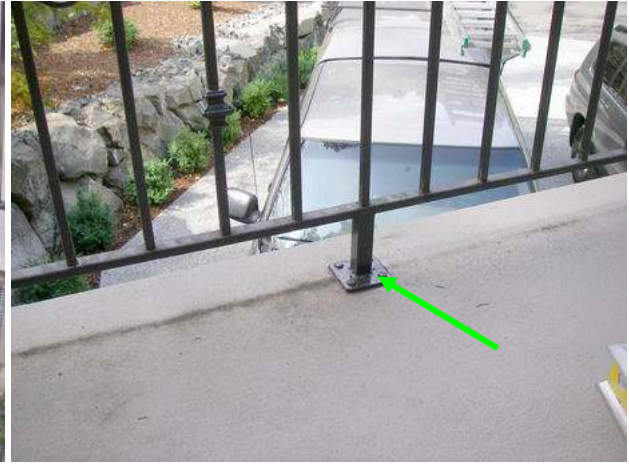
request confirmation that penetrations are sealed

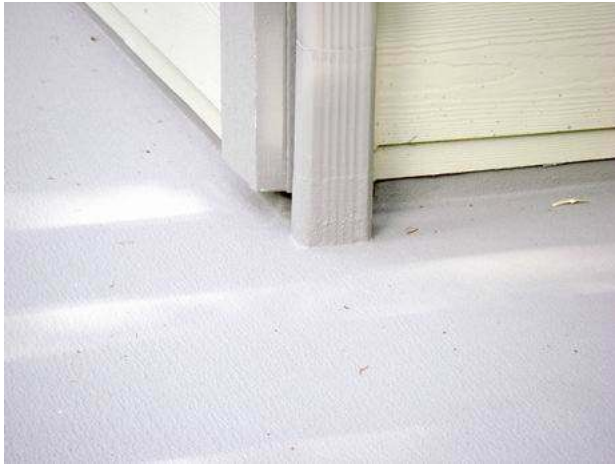
downspout penetrates deck membrane

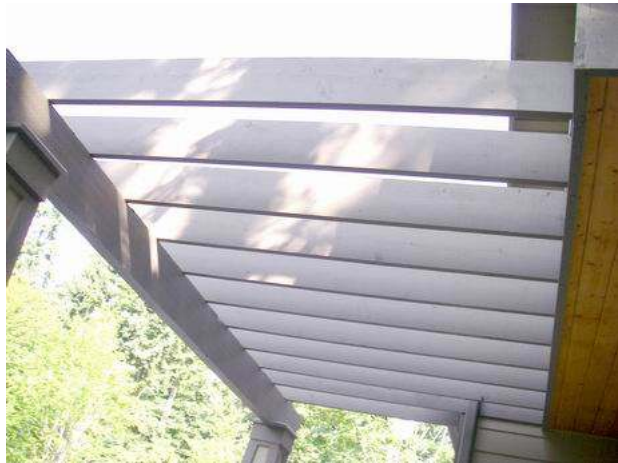
The arbor-type structure over the deck warrants mention. Although the beams are pressure-treated, the rafters are not. Unless well-protected from the elements, these members will eventually decay and require replacement. In addition, the column caps depend on caulk to keep moisture from entering the columns. Caulk is a poor substitute for flashing or other permanent water-sealing methods as it is an owner maintenance intensive material that requires vigilance and renewal.

untreated rafters on pressure-treated beam

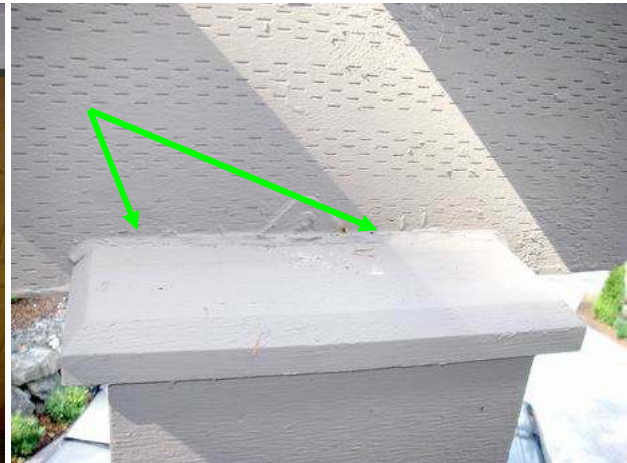
caulk here depended on for weathertight seal

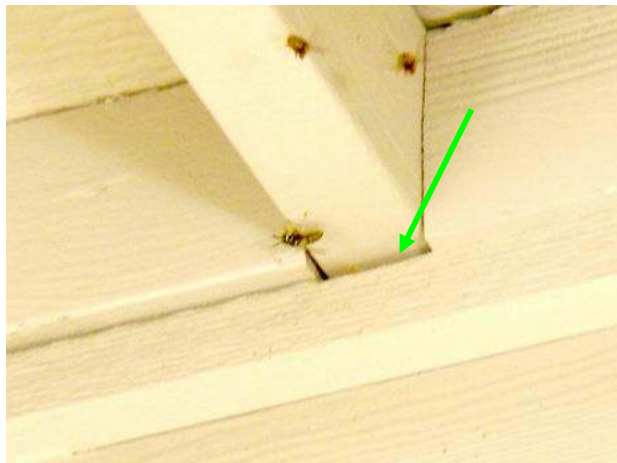
There is no access to the lower roof sub-areas (e.g., over the entry or bumpouts) and they are therefore exempted from this inspection and report. There may be deficiencies in this area that would have a negative effect on the value of this home. There is a very active bees' nest in the roof sub-area above the west bump-out; an exterminator should be retained.

insect access

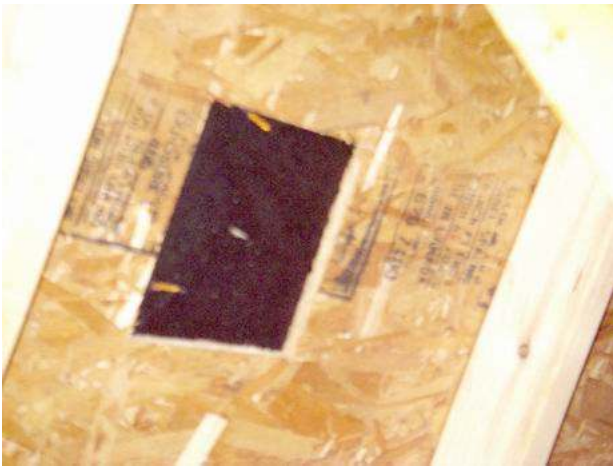
5
6 **Ventilation is substandard.** At least three of the holes cut through the sheathing have
7 been roofed over, and the installed roof ventilation does not meet the requirements (ten vents
8 for top roof, one each for main & entry roofs). At a minimum, attic ventilation should meet
9 the requirements documented in the prints. The air is currently dry and there are no signs of
10 condensation. The bathroom and laundry fans are ducted to the outside via roof vents (see ROOF
11 section).

14
15 *vent cut-out roofed over*

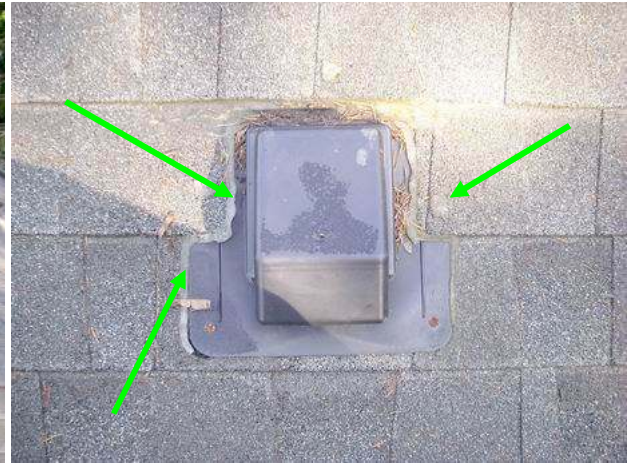
15 *caulk at all fan duct discharge vents*

10
11 **Due to the deficiencies noted, *an independent licensed roofing contractor* – other than**
12 **the one that installed the roof - should be retained to further evaluate all of the roof, roof**
13 **systems and flashings and implement the necessary corrections.**

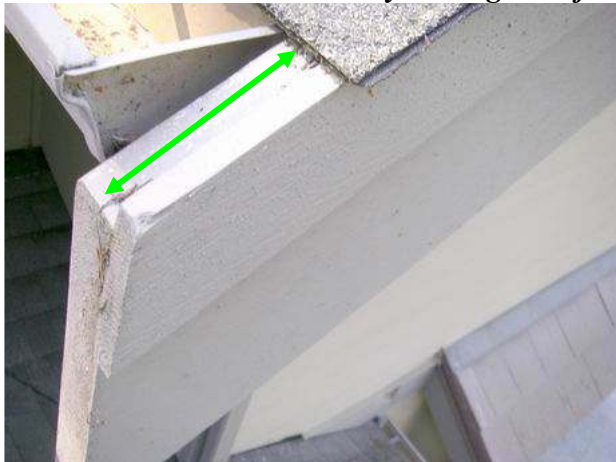
16 *exposed barge rafter end*

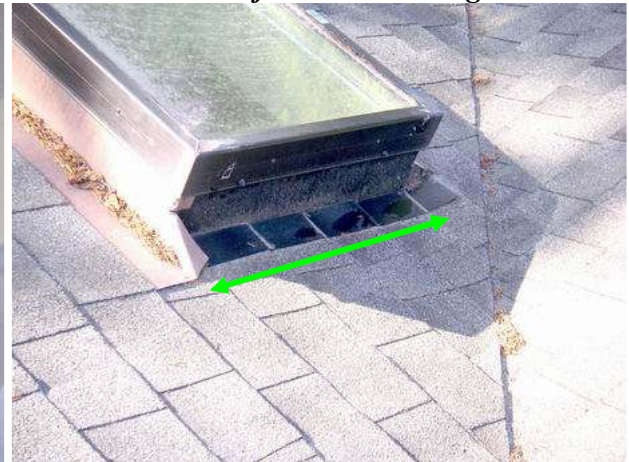
17 *step flashing installed on top of shingles*

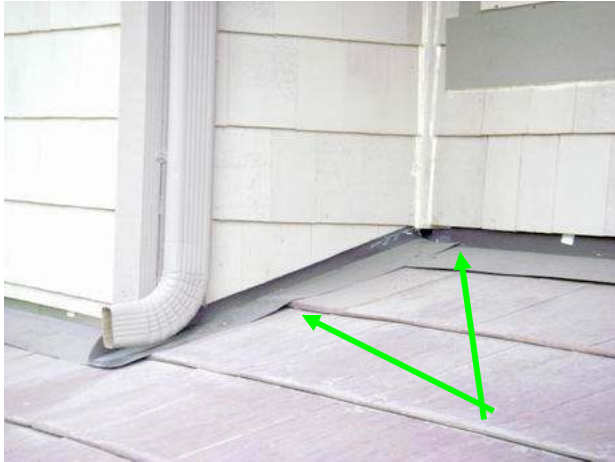
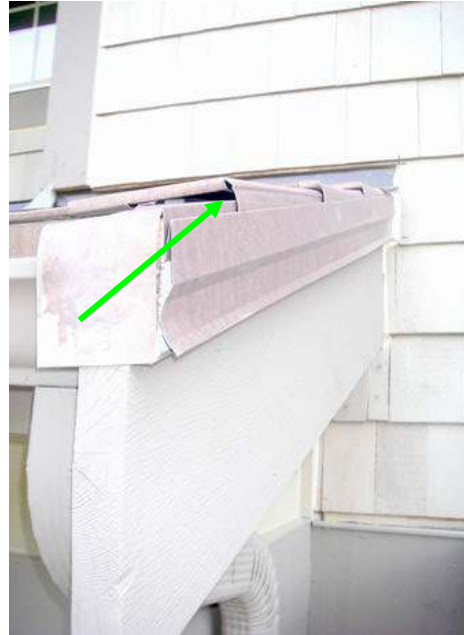
1 **There also appears to be avenues for moisture intrusion at the lower roof areas that**
2 **feature some type of metal roofing.**

3 *appear to be potential sources of moisture intrusion in a wind-driven rain*

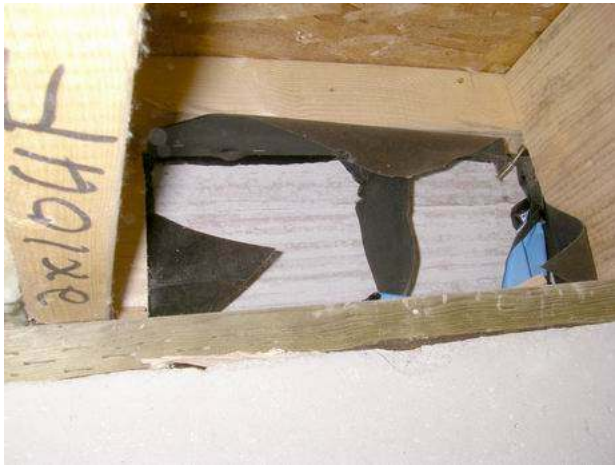
5
6 **Ventilation is technically inadequate; there are five vents when there should be six.**
7

8
9 *blocked crawl space vent*

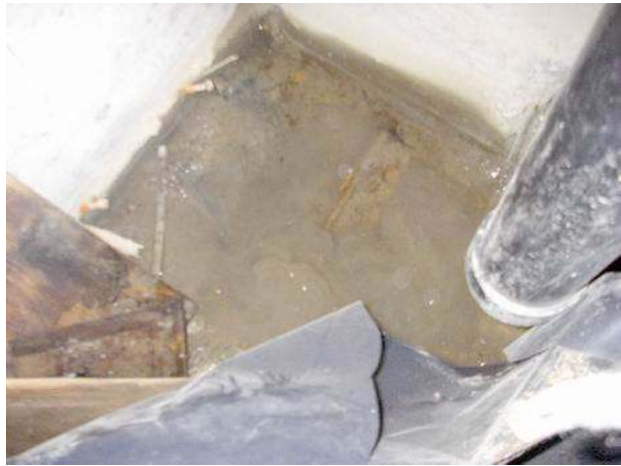
10
11 *standing water in northwest corner*

15 **Standing water was noted in the northwest corner of the crawl space. While not**
16 **unusual in new construction, standing water should not remain in the crawl space. The area**
17 **should be dewatered and then monitored to assure that it remains dry. No apparent**
18 **provision has been made for the possibility of moisture infiltration into this crawl space, i.e.,**
19 **no sump or BGD system was visible. In the event of moisture accumulation from any**
20 **source, percolation or evaporation appear to be the only methods of ridding this area of**
21 **excess moisture.**
22

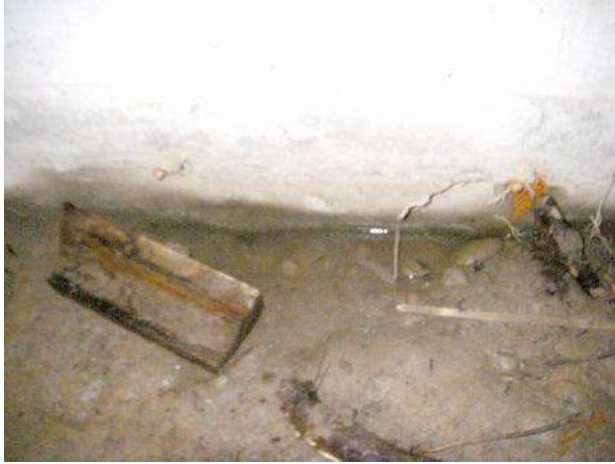
12 **Some construction debris was noted in random areas. All construction debris or**
13 **concrete formwork left in place by the builder should be stripped and/or removed from the**
14 **crawl space. This aids in eliminating an attraction for wood-destroying insects or organisms.**

cellulose debris in crawl space

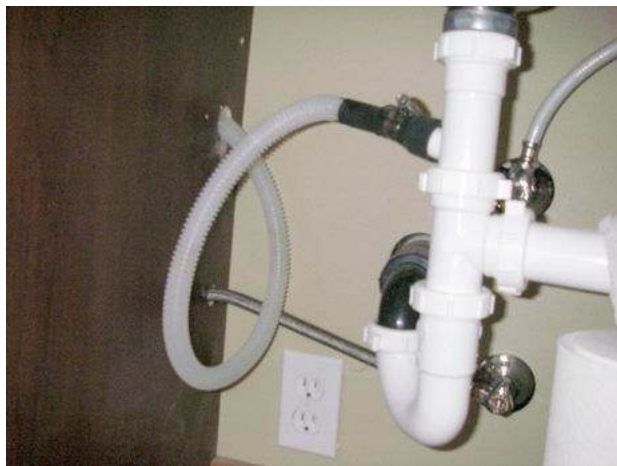
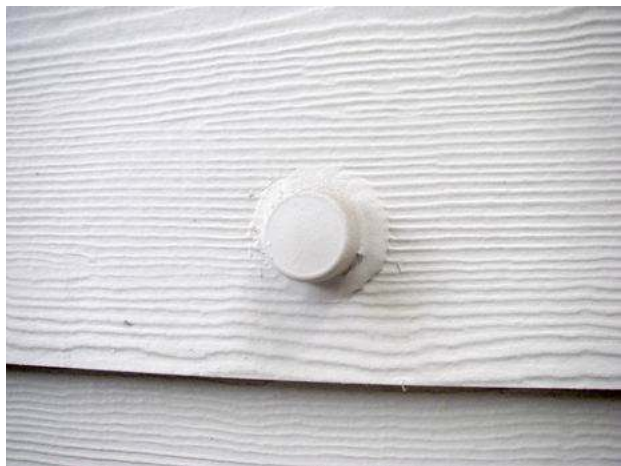
18 *improper loop by-passes the air gap* *exterior air gap (should be drilled for air passage)*

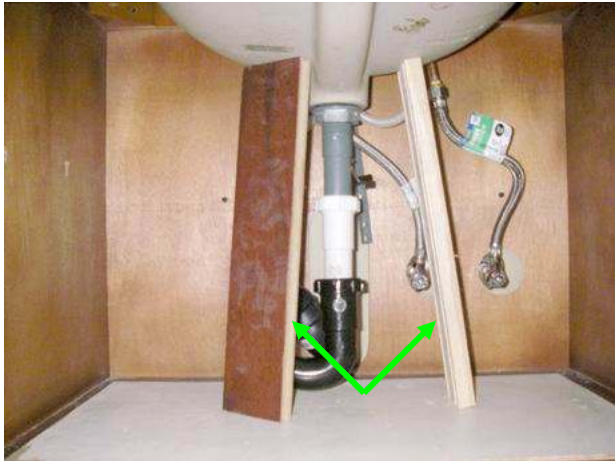
12
13 The vitreous china sink, solid surface vanity top, and faucet are in serviceable condition.
14 **Scrap wood kickers are still in place under the sink that appear to be holding the sink in**
15 **place. Insuring that the sink is properly supported without the kickers prior to move-in is**
16 **recommended.** There are no noticeable leaks in the faucet, the P-trap drain assembly, or the water
17 supply lines.
18

19 *kickers under sink*

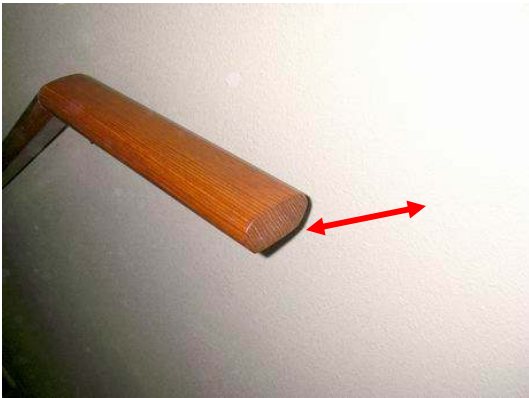
12
13 *handrail with no return to wall*

16 **The handrail in the stairwell to the garage is substandard in that the ends of the**
17 **handrail do not "return" to the wall.** Some of the walls and concrete slab floor are
18 **obstructed with stored material and could not be inspected.** The visible portion of the floor is
19 **in serviceable condition, with normal settling cracks.** **The access door to the crawl space should**
20 **be a solid-core fire-rated door to maintain the proper fire-rating between the garage and the**
21 **rest of the house.**

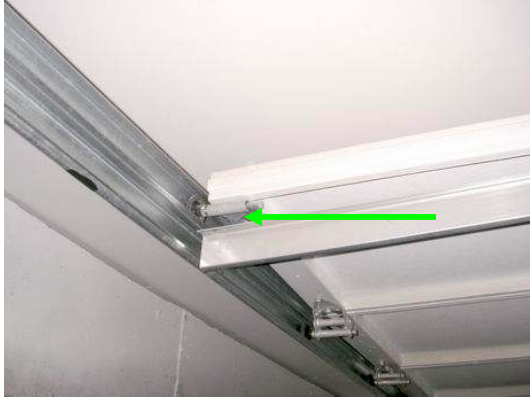
22 The garage doors are controlled by electric garage door openers. The openers are
23 functional, as are the safety stops. **The north safety-stop light-beam bracket is loose and should**
24 **be tightened.** **The top rail on the south garage door is not properly secured on the south side.**
25 **The rail is designed to reinforce the garage door panels and prevent them from sagging.** The
26 **rail should be properly secured in the same fashion as the rails on the rest of the garage**
27 **doors.** The access door to the living area is equipped with a deadbolt lock. The self-closing hinge
28 on the access door is functional. The electrical receptacles tested have correct polarity and
29 grounding and one is a GFCI device. **The built-in vacuum cleaner is not yet installed and no**
30 **visible exhaust was noted.** **Built-in vacuums are required exhaust to the exterior.**

loose garage door bracket
