GENERAL BUILDING INSPECTION REPORT FOR
XXX South AAA Street, Seattle, Wa.
FOR THE EXCLUSIVE USE OF Happy Clients

November 16, 2008

cover letter, 24 page report

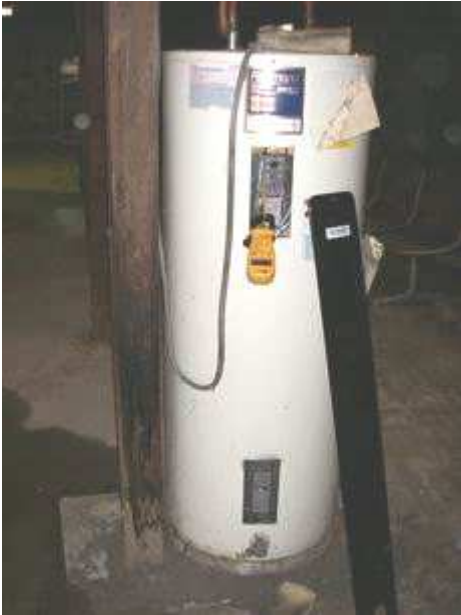
26
27 The visible plumbing system has a combination of copper and galvanized water supply
28 lines, a combination of ABS plastic and cast iron drain-waste-vent lines, and a Richmond electric
29 water heater of 50 gallon capacity. **The water heater is approximately fourteen years old and is**
30 **likely nearing the end of its useful life; the average lifespan of water heaters is eight to twelve**
31 **years. Budgeting for a new unit in the foreseeable future would be prudent.**

32
33 The water heater is equipped with a pressure relief valve and discharge pipe. The pressure
34 relief valve is set to open at either 150 psi or 210 degrees F. Earthquake restraining straps have not
35 been installed. Both elements are functional and set at 120°. The recommended setting for homes
36 with children and the maximum allowable setting for rental houses under the state landlord-tenant
37 act is 120 degrees F. This is to prevent the possibility of scalding from hot water coming directly
38 from the water taps.

Richmond electric water heater

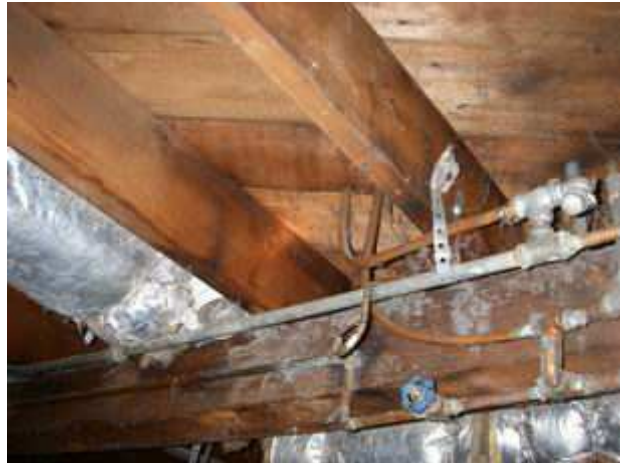
copper and galvanized water supply lines

11
12 **A note on galvanized water lines: low water volume will usually develop in time with**
13 **galvanized water lines. These lines acquire a corrosion build-up on the inside of the pipe**
14 **over time, reducing the water flow. When the water volume falls below "livable" levels, they**
15 **will have to be replaced, and some of the water lines in this home appear to be at that stage.**
16 **Additionally, the unions where sections are joined together (any threaded area) also corrode**
17 **over time, having a tendency to leak. The typical life span of galvanized water lines is from**
18 **thirty to fifty years.**

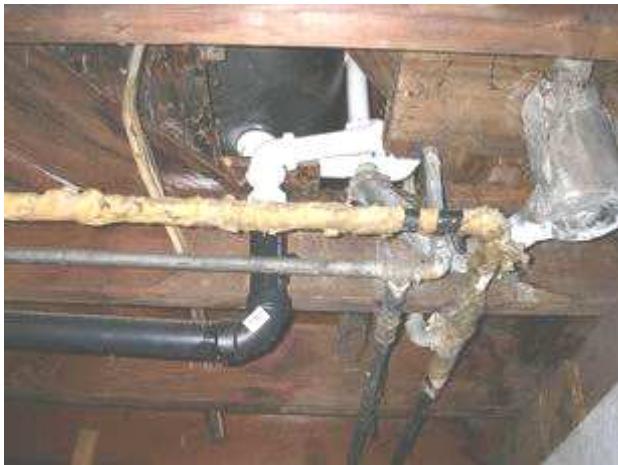
- 2 • convoluted waste piping from bathtub that prevents water from draining properly;
- 3 • and does not include a P-trap;
- 4 • no P-trap in master bath shower drain;
- 5 • “Y” fitting from main bath vanity installed backwards so water must flow uphill
- 6 before draining;
- 7 • both the bathtub and shower drains leak;
- 8 • improperly fitted union;
- 9 • no venting for roughed in kitchen sink drain;
- 10 • vent for laundry incomplete and terminating in closet;
- 11 • flexible water hoses for laundry disappear into wall and cannot be checked for
- 12 tightness or leaks, or shut off.

14 *convoluted waste piping with no P-trap*

19
20 **Much of the plumbing and virtually all of the waste plumbing (DWV) is substandard**
21 **and must be redone. The exceedingly poor quality plumbing work in this home indicates an**
22 **absence of knowledge that is remarkable as well as hazardous to future occupants (the**
23 **absence of P-traps at the bathing facilities will allow sewer gas – poisonous and explosive as**
24 **well as fragrant – into the home).**

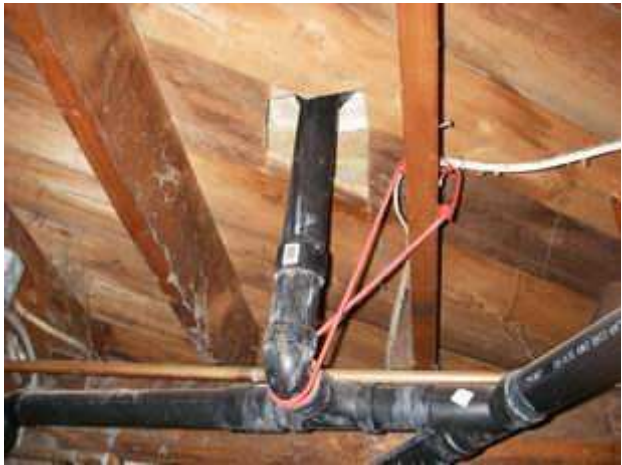
15 *no P-trap at shower drain (note pipe hanger)*

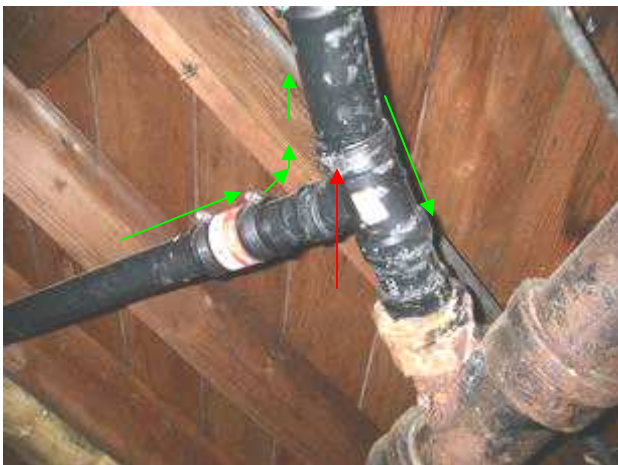
17 *water must flow uphill prior to draining & one union attached at sharp angle*

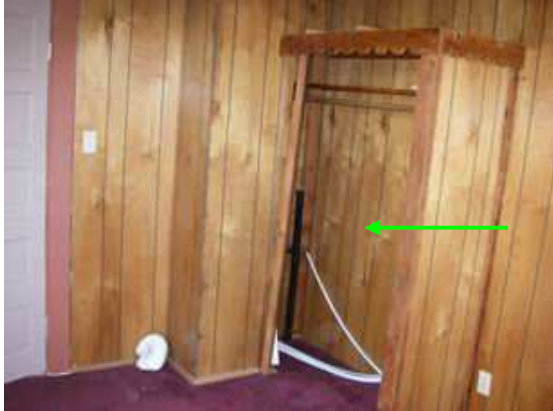
laundry vent capped in "closet"

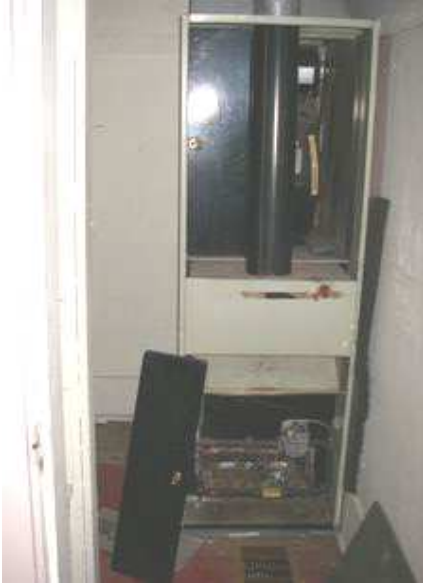
The furnace location is illegal; gas furnaces are not allowed in bedroom closets unless significant safety measures are taken (e.g. self-closing air-tight door, proper combustion air source, etc.). The gas line to the furnace has a small gas leak; this must be repaired as soon as possible to prevent "unplanned detonation" the gas company euphemism for explosion.

Removal of the furnace panel cover revealed a weak diffused or non-existent flame cone and fluctuating flame characteristics, indications of improper burning and the need for servicing and possibly new burners. Due to the design, none of the heat exchanger is accessible to inspection without dismantling the furnace. **Radial play in the blower shaft and bearings is excessive and some wobble could be felt in the squirrel cage fan, and a noticeable growl could be heard from the cold air return. There is no filter in place and the drive belt is cracked over half way through.**

Payne naturally-aspirated furnace in bedroom closet

9 **Due to the defects noted, a qualified HVAC contractor should further evaluate this**
10 **furnace and furnace installation and repair or service as necessary, with special attention**
11 **to establishing the condition of the heat exchanger and bringing the heating system into**
12 **compliance with local regulations.**
13

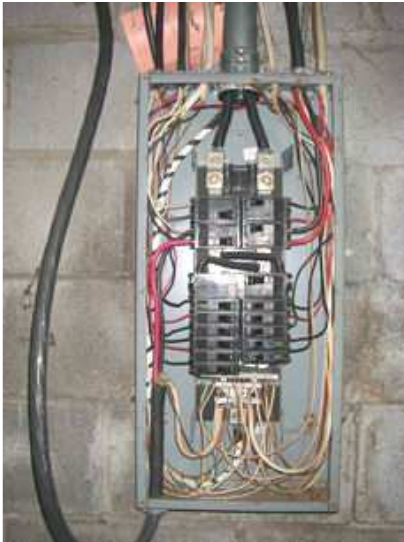
2
3 The 120-240 volt overhead electrical service is connected to a General Electric split bus
4 200 amp circuit breaker panel on the east wall of the basement. Removal of the service panel
5 cover reveals aluminum 4/0 service entrance cable (from meter to panel), copper branch wiring
6 (from panel to house), and a 100 amp sub-main disconnect for the household circuits. **The system**
7 **was grounded to the plumbing system but the system ground is no longer operational due to**
8 **the insertion of plastic pipe between the grounding wire and the earth.**

19
20 *General Electric circuit breaker panel*

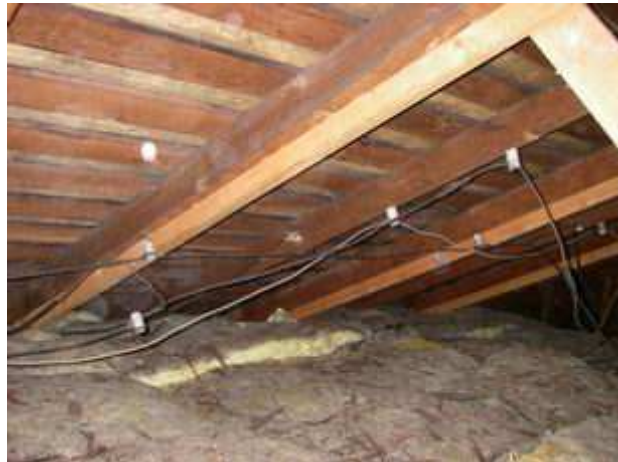
13
14 **The knob and tube wiring in the attic has been buried under the fiberglass batt**
15 **insulation, a common but forbidden practice.** It should also be noted that many insurance
16 companies today will not insure homes with knob and tube wiring. A discussion with the
17 client's insurance vendor on this point is highly recommended.

21
22 *“live” knob and tube wiring in attic*

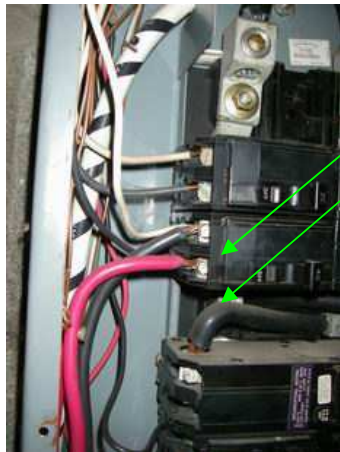
- 3 • **a double tap in the panel that has;**
- 4 • **#12 branch conductors being fed by a 40 amp circuit breaker;**
- 5 • **live conductor not properly terminated;**
- 6 • **improper branch wiring components at exterior;**
- 7 • **exposed lamp fixture splice;**
- 8 • **energized knob and tube wiring buried under insulation in the attic;**
- 9 • **sump pump conductors at risk.**

11
12 *double tap in panel*

16
17 **Due to the defects noted, a licensed electrician should be retained to survey this entire**
18 **electrical system and make the necessary corrections.**

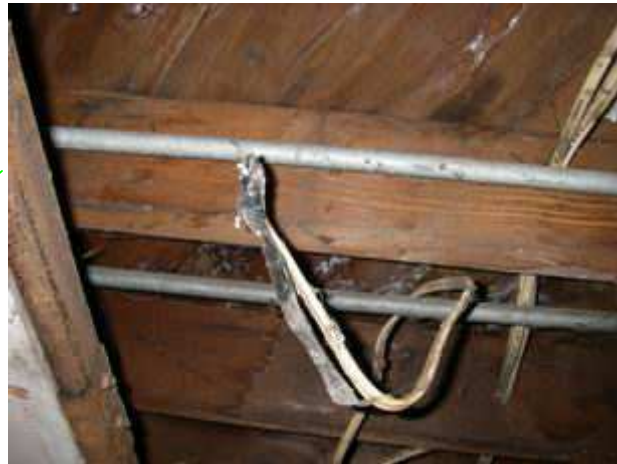
13 *“live” conductor not properly terminated*

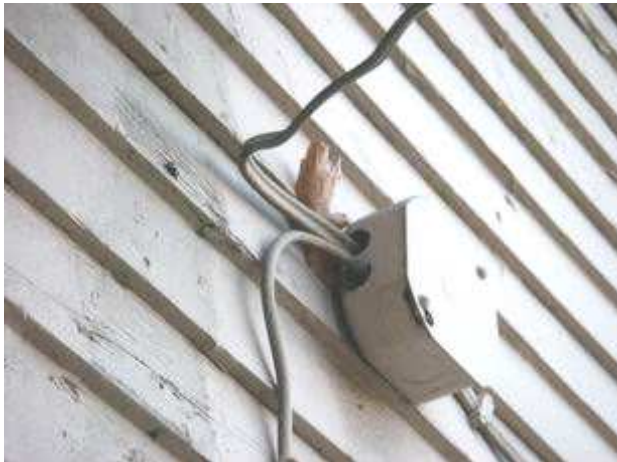
14 *improper wiring (materials and methods)*

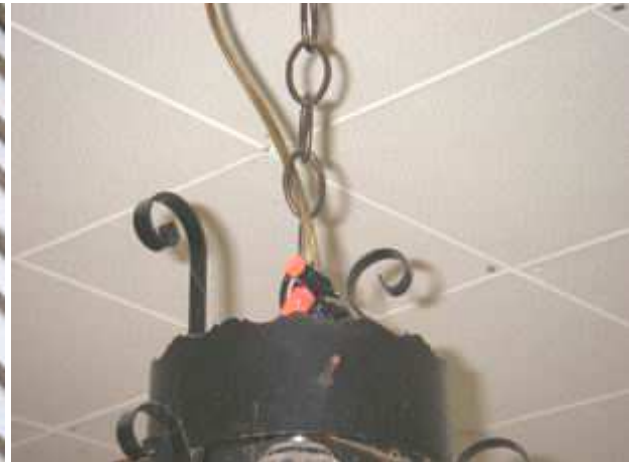
15 *improper interior lamp splicing*

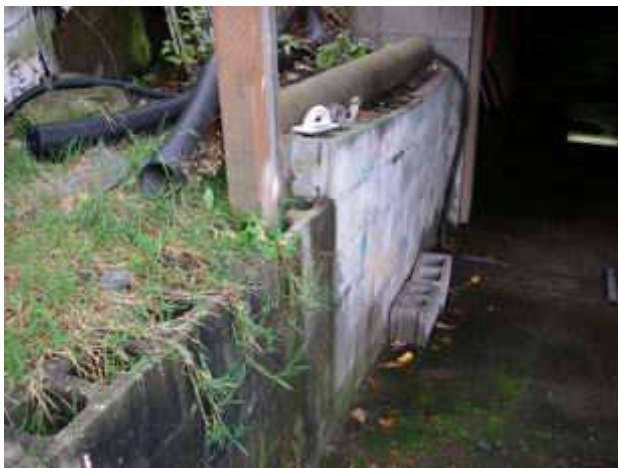
4
5 The concrete driveway is in serviceable condition, **although cracked in multiple places.**
6 Sealing the driveway cracks with epoxy is recommended to reduce moisture intrusion under the
7 slab and prevent weed growth in the cracks. **The block retaining walls at the driveway are not**
8 **properly built (they should be level) but do not appear to be failing at this time. The**
9 **settlement at the front walkway is significant and creates a trip hazard. The steps down to**
10 **the sidewalk as well as the steps from the back door should have the requisite handrails**
11 **installed.**
12

13
14 *driveway retaining wall*

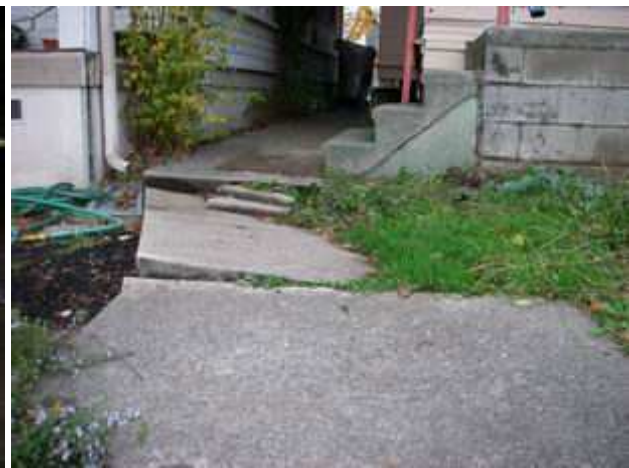
15
16 *trip hazard near front porch*

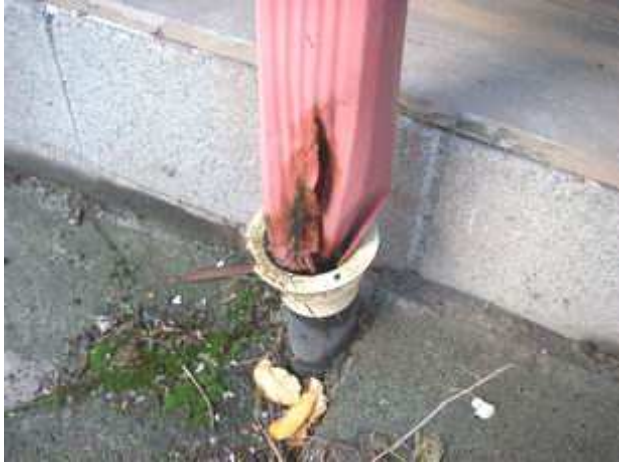
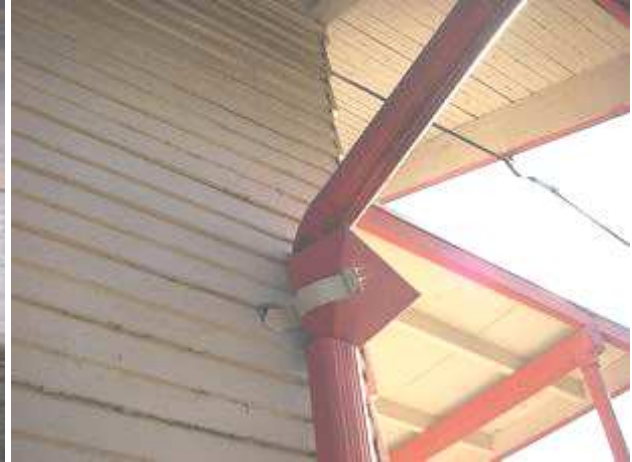
18
19 **The roof drainage could use attention. The reducers at some of the downspouts drop**
20 **the size significantly, creating narrow passages that are easily obstructed. Some of the**
21 **downspouts are not connected to either splashblocks or drain lines. This allows water to run**
22 **directly into the soil at the foundation, possibly adding moisture to the basement or bearing**
23 **soil under the footings. Splashblocks should be added to direct roof run-off away from the**
24 **foundation, and the soil sloped for positive drainage away from the structure. Some of the**
25 **downspouts do flow into below grade drain lines (BGDLs) that probably empty into a community**
26 **storm drain. The BGDLs should be flushed annually with a garden hose to ensure that they are not**
27 **plugged or collapsed. The operation and discharge of the underground drain lines is not included in**
28 **the scope of this inspection. Plugged drains are a common cause of water leakage into basements**

7
8 *reducers of questionable value*
9

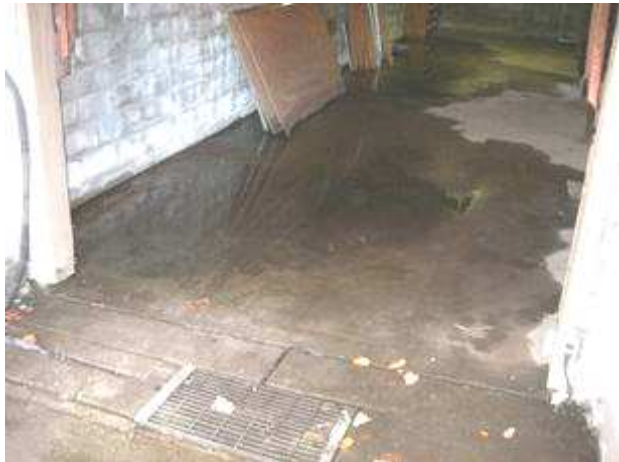
1 **The run-off from the driveway is flowing into the basement, and neither the floor**
2 **drain in the basement nor the sump-pump in the driveway is operational.** The sump pump is
3 not a professional installation as both the discharge hose and the wiring are at some risk
4 from vehicle traffic. The pump should be properly replaced by a qualified drainage
5 contractor and/or other steps taken to assure a dry basement.
6

10
11 *ponded water in basement (pump under grate)*

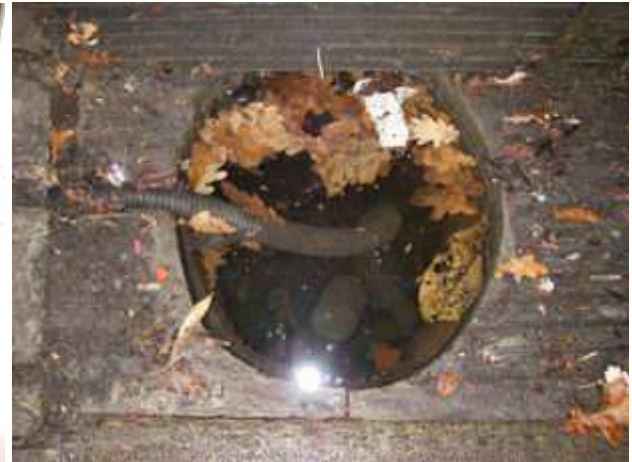
non-functional sump pump

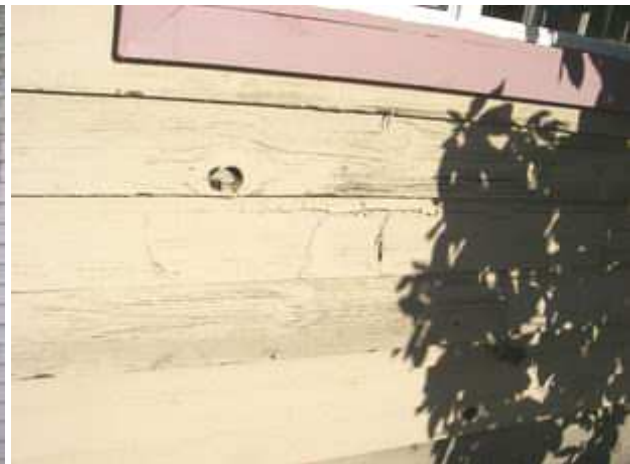
27 *deteriorated clapboard siding*

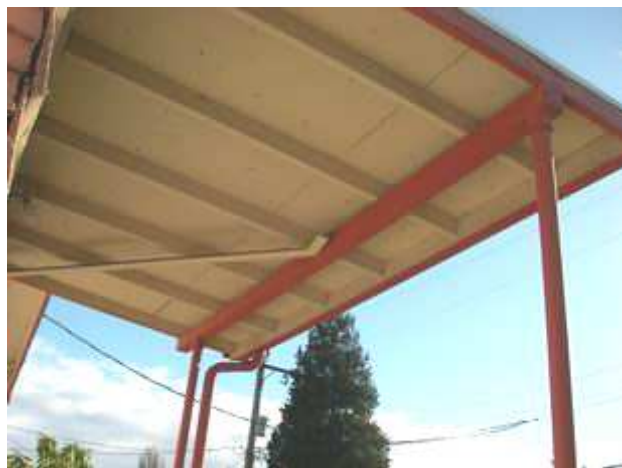
The framing of the front porch roof is substandard (a 4x4 is used as the main supporting beam) and could fail under a heavy snowload; it should be removed, replaced, or properly reinforced by a qualified and licensed contractor.

substandard porch roof framing

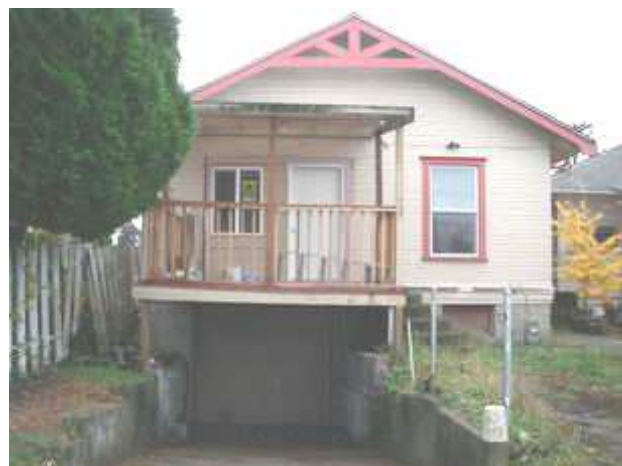
The rear deck and attached roof are in poor condition from both sub-standard construction and fungal decay and should be removed and/or replaced.

sagging, swayback and un-level deck

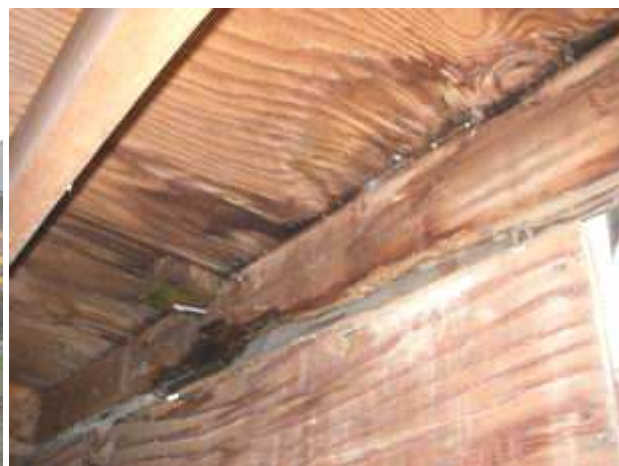
decay in deck framing

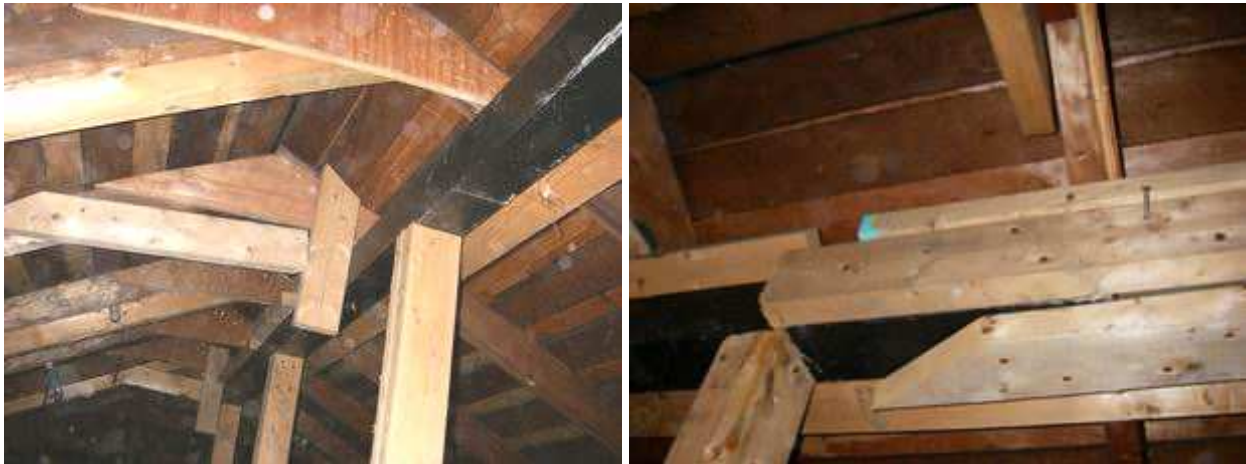
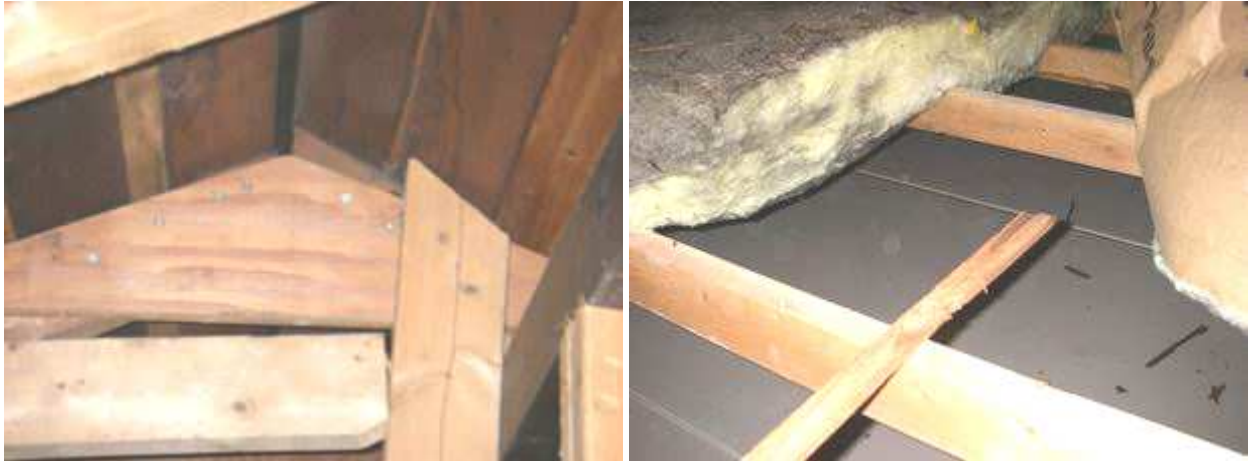
12
13 **There has been some unusual movement of the framing and resultant repairs or**
14 **corrections of somewhat dubious validity** **Where the top of the rafters come together at the**
15 **ridge (or peak), the east rafters over the main area have dropped almost an inch in relation**
16 **to the rafters on the west side.** **Some of the original joists have been removed, again from the**
17 **east side.** Retrofit support has been added in the form of plywood gussets at the peak, a 4x4
18 used as an offset ridge beam, 2x4 kickers in various areas and new 2x4 joists. The cause or
19 reason for the original rafter movement was not apparent but could have been due to
20 removal of the original joists. Whether or not the retrofit framing augmentation is adequate
21 to arrest the framing movement can only be determined by a licensed structural engineer. If
22 these modifications were not designed by a licensed structural engineer, then an engineer

26
27 *different views of retrofit roof framing & augmentation*

23 should be retained to further inspect/evaluate the framing changes to determine if the
24 corrections are adequate and to issue a report that can be used at resale.

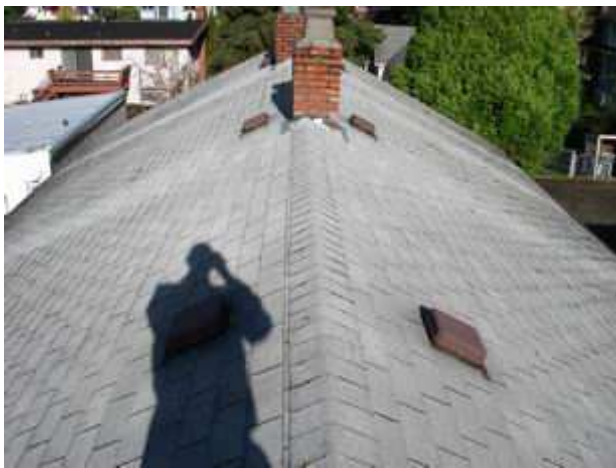
13 *three-tab shingle roof*

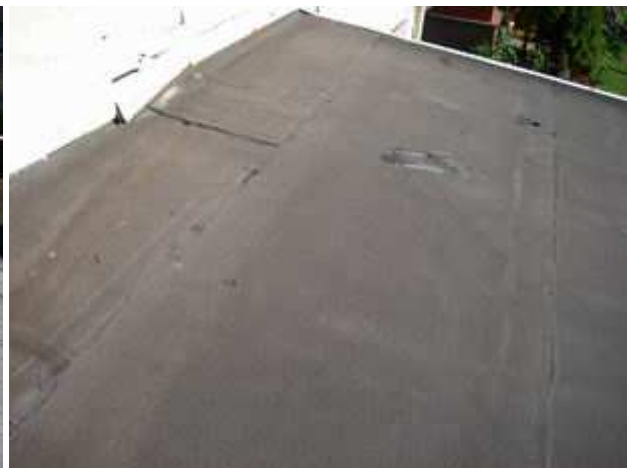
1 The front porch roof covering is composed of layers of single-ply modified bituminous
2 asphalt over a layer of fiberglass sheeting. Commonly called a "torchdown" roof, the material is
3 usually guaranteed by the manufacturer for 12 to 15 years. **Because ultraviolet rays can damage**
4 **the asphalt, the roof should have been coated with a reflective material after a 60 day**
5 **"curing" period; this is required by many manufacturers to keep the warranty in force.**
6 Some products, such as Reflective Emulsion #1845 by American Tar Co. are designed for this
7 purpose.
8

14 *torchdown roof over front porch*

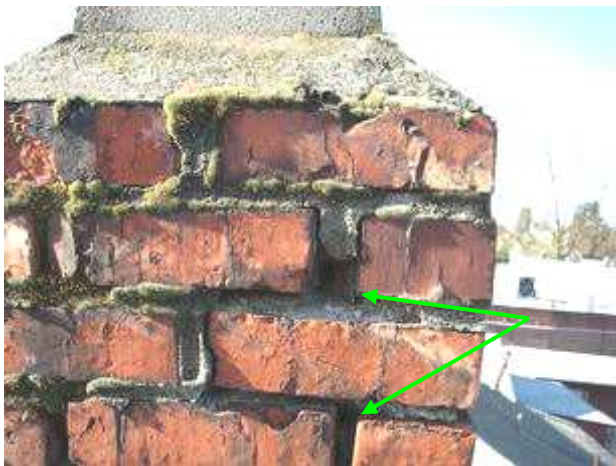
15 *deteriorated mortar in chimney*

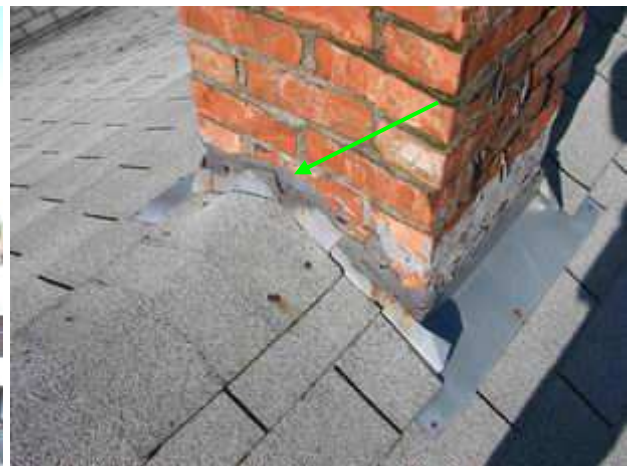
21 The roof consists of one tier of three-tab asphalt/fiberglass composition shingles. No
22 significant defects were noted in the roofing or shingle installation **but the counter-flashing at the**
23 **chimney was omitted and the resultant voids sealed with mastic. Both chimneys are in**
24 **deteriorated condition with soft and missing mortar and will need significant repair; the**
25 **counterflashing should be replaced when the repairs are commenced.**

16 *moisture intrusion at missing counter flashing*

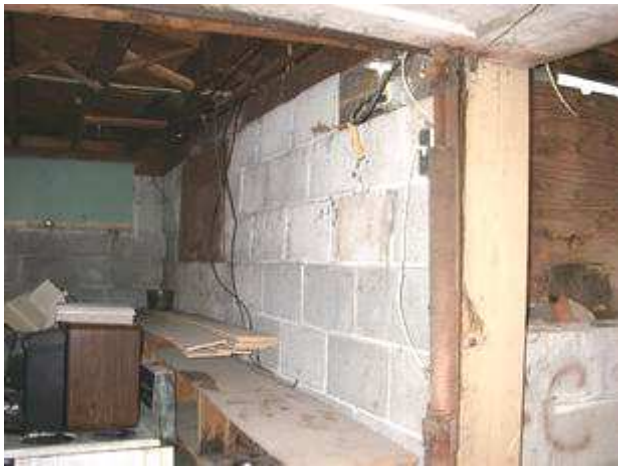
8 **The north concrete block stem wall has a horizontal fracture line in the mortar and**
9 **evidences a slight rotation at the top. It appears that the concrete stoop is attached to the**
10 **wall, either through friction or mechanical means and the wall is rotating with the stoop.**
11 **Although movement is incremental, it will continue unless the stoop movement is arrested.**
12

25 *top three rows of block are rotating outward*

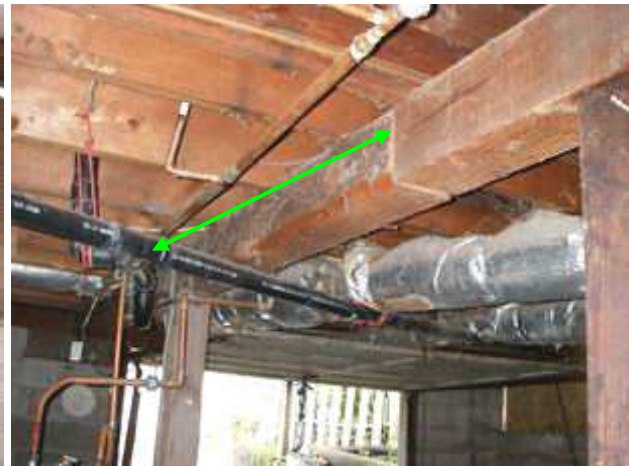
26 *excessive beam cantilever*

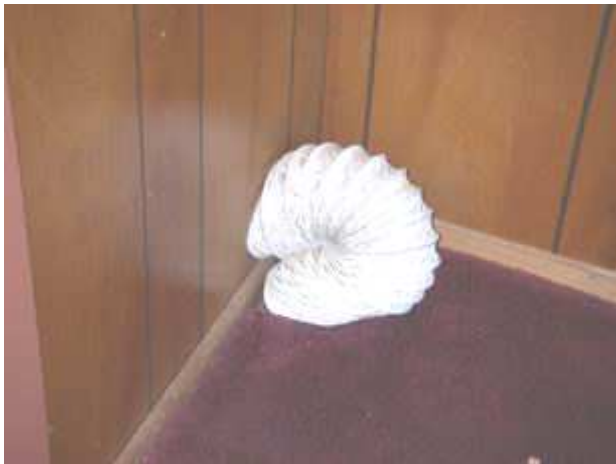
8 **The laundry facilities are defective and should be replaced.** Although the mismatched
9 Kenmore washer and General Electric dryer are functional, **the washer hoses are routed to the**
10 **inside of the wall and the control valves are not accessible.** The flexible plastic dryer duct
11 (now illegal) is routed through the wall into the bedroom and then down through the
12 bedroom floor into the basement, where the duct terminates, discharging warm moist air and
13 lint into the basement.
14

17 *dryer duct routed through bedroom*

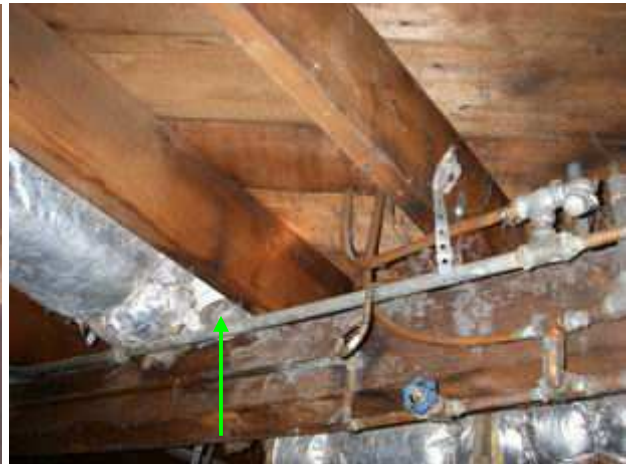
18 *dryer duct discharge*

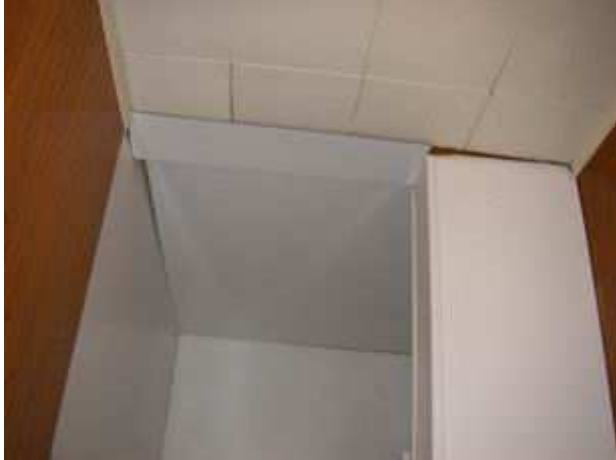
22
23 **The fit and finish of the components – including the walls and ceilings, is of poor,**
24 **unfinished and/or amateur quality; this room will require a total do-over.**
25

9
10 *partial view of master bath ceiling*

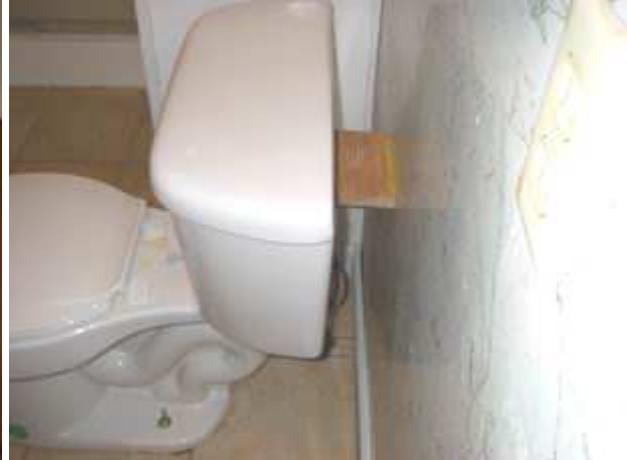
1 The commode functions properly and is solidly mounted **but the tank is spaced from the**
2 **wall – and possibly reinforced by a wood block spacer.** Water volume (flow) is adequate when
3 two fixtures are used simultaneously.

11 *wood block supporting toilet tank*

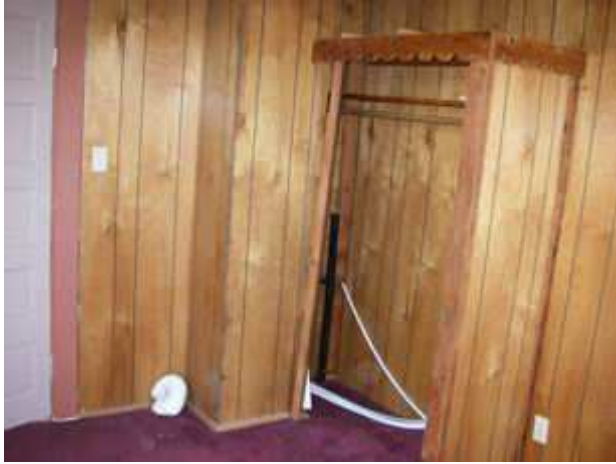
“closet” in master bedroom

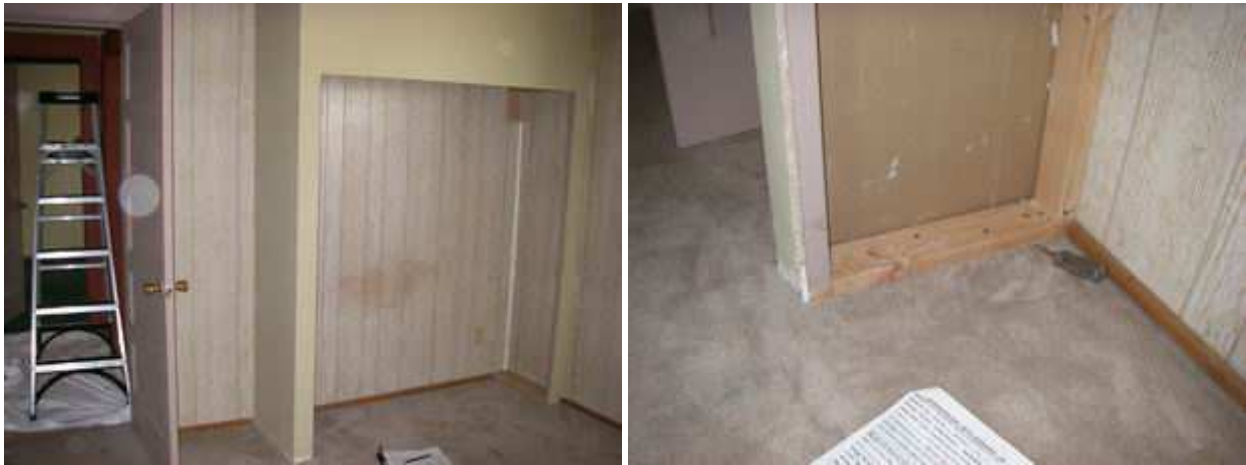
2
3 No significant defects were noted in the glass or seals of the dual pane windows. **The**
4 **entry door does not latch properly. The unfinished closet framing has been placed over the**
5 **carpet so it should be removed and replaced when the carpet has been removed.** **This closet**
6 **is only 20½ inches deep and 70½ inches high.** The electrical receptacles tested have correct
7 polarity and grounding. Heat for this room is provided by a forced air heat register. ***This room***
8 ***should not be used as a bedroom as long as the furnace is in the unprotected closet.***
9

10
11 ***unfinished closet with substandard framing built on top of carpet with 5' 10" high opening***
12
13
