**GENERAL BUILDING INSPECTION REPORT FOR**  
**1111 11th Avenue, Seattle, Wa.**  
**FOR THE EXCLUSIVE USE OF New Construction**

May 2, 2000

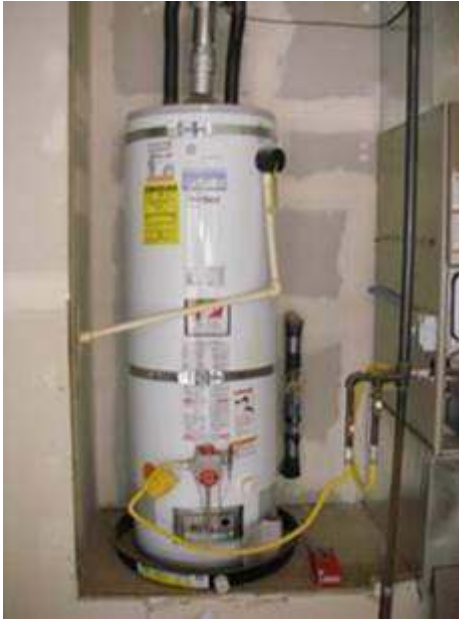
20 The water heater is equipped with a temperature-pressure relief (TPR) valve and discharge  
21 pipe. **The routing and workmanship of the discharge piping for the TPR valve appears to be**  
22 **below the “workmanlike and professional” standard required.** The pressure relief valve is set  
23 to open at either 150 psi or 210 degrees F. **There is no expansion tank in place; a conversation**  
24 **with the local permitting agency on this point is recommended as they are required in most**  
25 **jurisdictions.** Earthquake restraining straps are in place. **The lower strap is higher than it**  
26 **should be; it should be in the lower third of the tank height.** Removal of the inspection plate  
27 and "roll out" shield revealed a strong blue flame which is a sign of proper burning. Using the TIF  
28 8800 combustible gas detector, the gas supply lines were checked for natural gas leaks and none

4  
5 *note discharge pipe and lower earthquake strap*

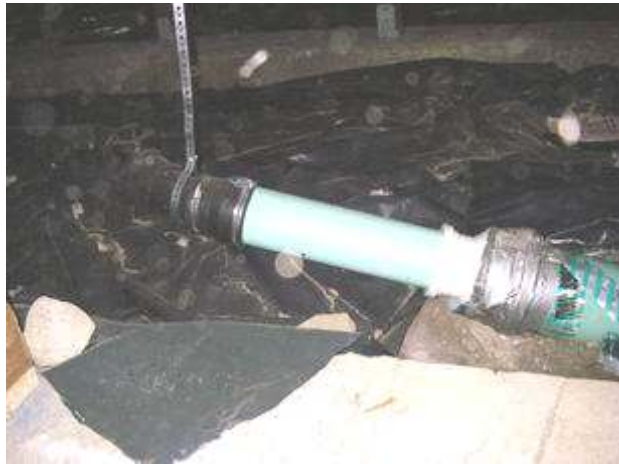
1 **Under the vapor barrier, the sewer line has been improperly spliced with no hub**  
2 **fittings and it appears the leak-proof integrity depends on duct tape.**  
3

6  
7 *“spliced” sewer pipe*

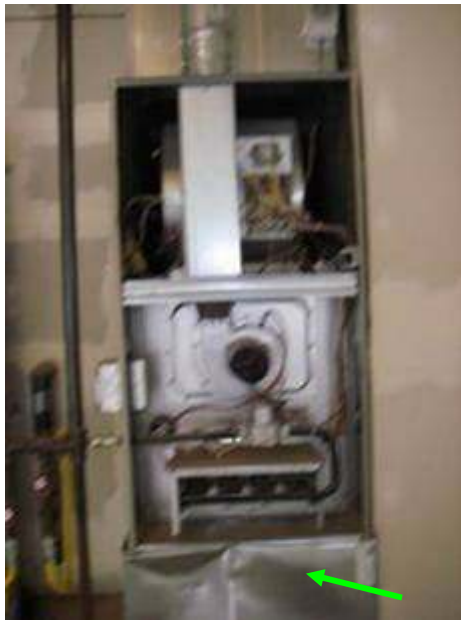
21  
22 Removal of the furnace panel cover revealed a strong blue flame and good flame  
23 characteristics. Due to the design, none of the heat exchanger is accessible to inspection without  
24 dismantling the furnace. The ignition source is located a minimum of 18 inches above the  
25 garage slab floor. **An impact barrier that would prevent driving into the gas line has not**  
26 **been installed, as evidenced by the impact damaged lower (supply) plenum.**

11  
12           *Armstrong furnace (note damaged plenum)*

13  
14 **Due to the concerns over the installation, it is highly recommended that the heating**  
15 **industry trade inspection group (Northwest Sheet Metal Inspection Service - contact**  
16 **Wayne Estes @ 206-849-0373) be contacted for a thorough, highly-detailed but free**  
17 **inspection/review of the installation for possible improvement recommendations and**  
18 **corrections to the installation. These inspections are provided at no cost. Any required**  
19 **work should then be completed.**

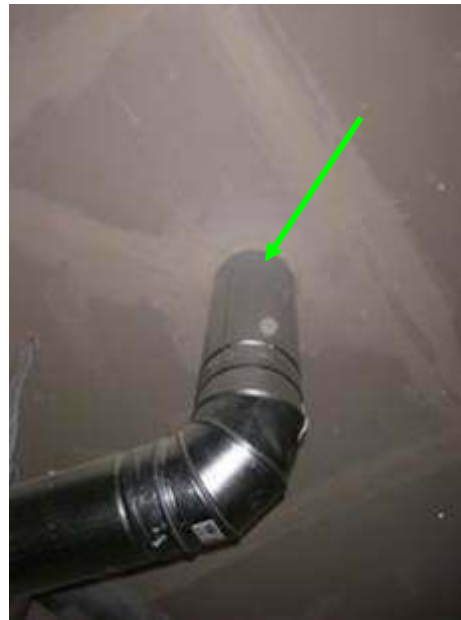
5  
6           The requisite one-inch clearance between the b-vent exhaust flue and the  
7 surrounding ceiling wallboard has not been achieved. A one-inch clearance to  
8 combustibles is required around all b-vent flues but in a garage the gap must be covered  
9 with sheet metal to retain the fire-rating.

13  
14           *one-inch clearance required here*

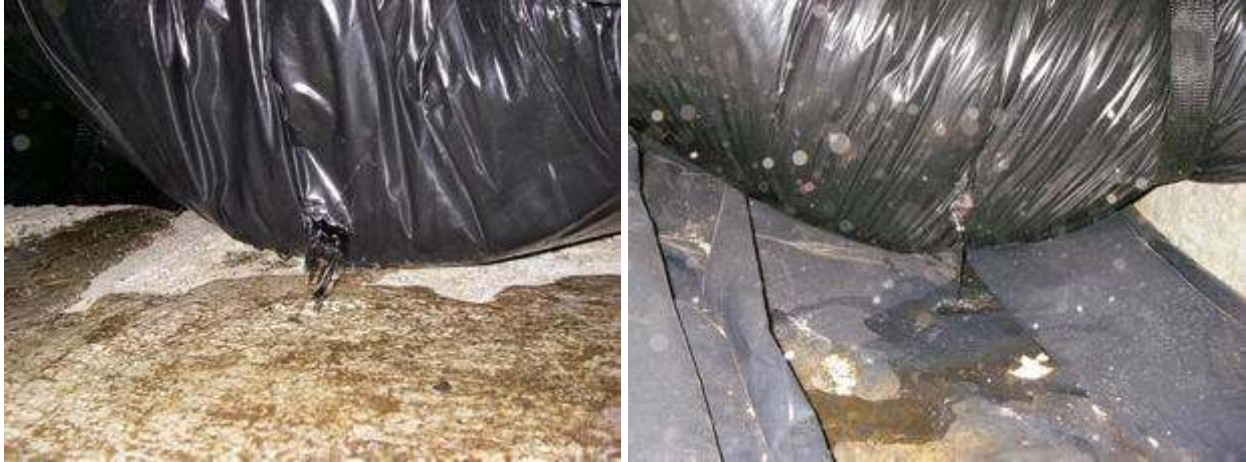
2  
3 *heat ducts blocked by accumulated water*

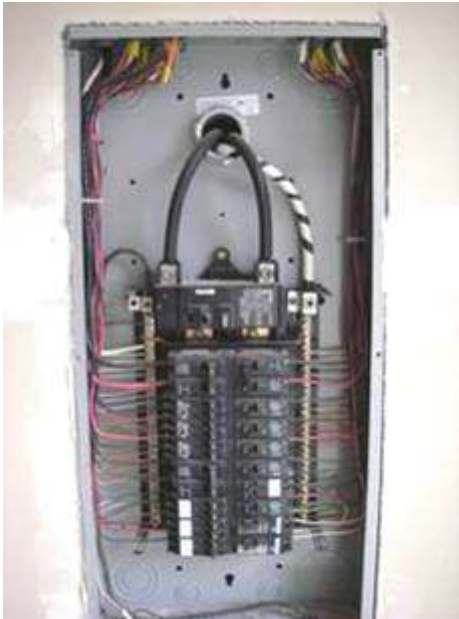
1           **There is a 240-volt breaker marked ‘water heater’ of unknown purpose (the water**  
2 **heater is gas-fired); a written dialogue with the builder on this point is recommended. One**  
3 **of the conductors in the crawl space is not properly secured to the framing.**  
4

5  
6           *circuit breaker panel*

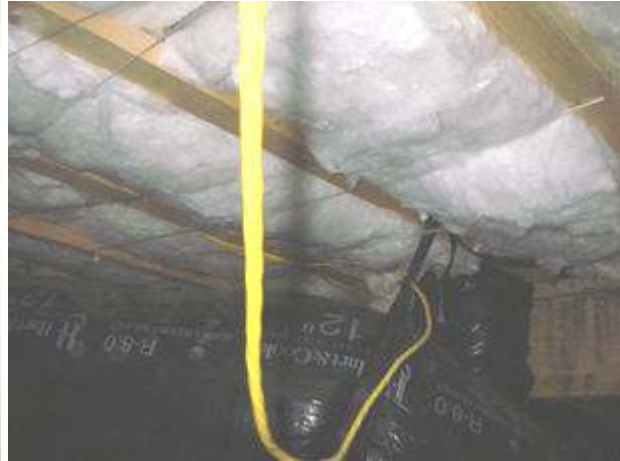
7           *sagging conductor*

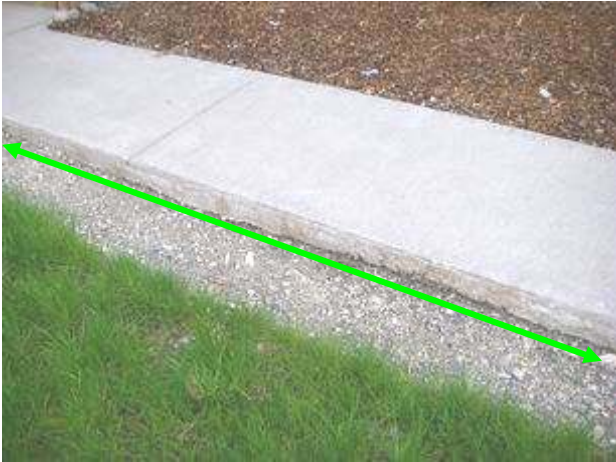
19           The concrete driveway and walkways are in serviceable condition. **The exposed edges of**  
20 **any concrete flatwork should be embanked to prevent undermining of the concrete.**  
21  
22

*embank bottom of walkway*

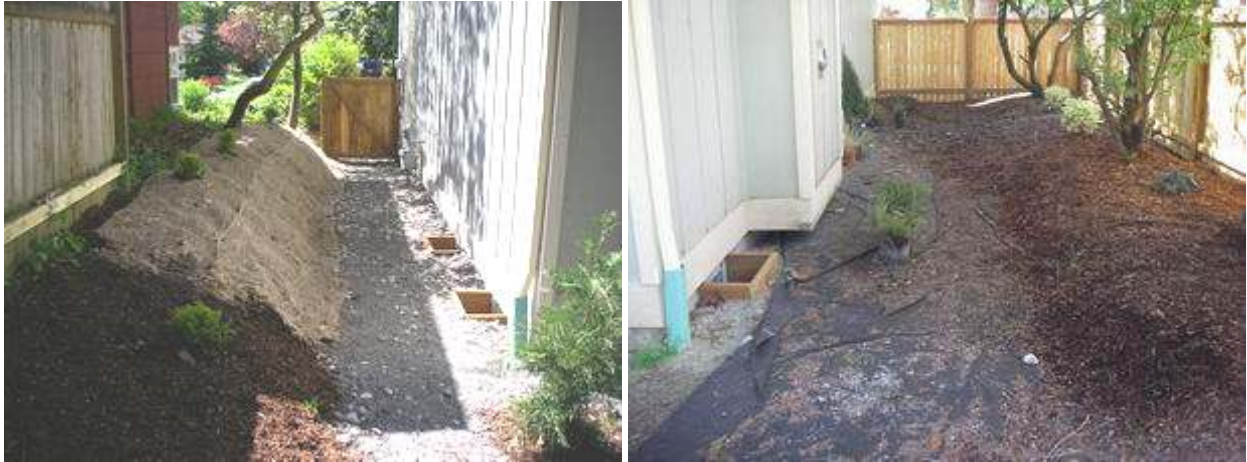
**The home sits in a bit of a depression, with the soil sloping towards the home on at least three sides. As required, the grade away from the foundation walls “shall fall a minimum of six inches within the first ten feet”.**

*improper soil slope around home*

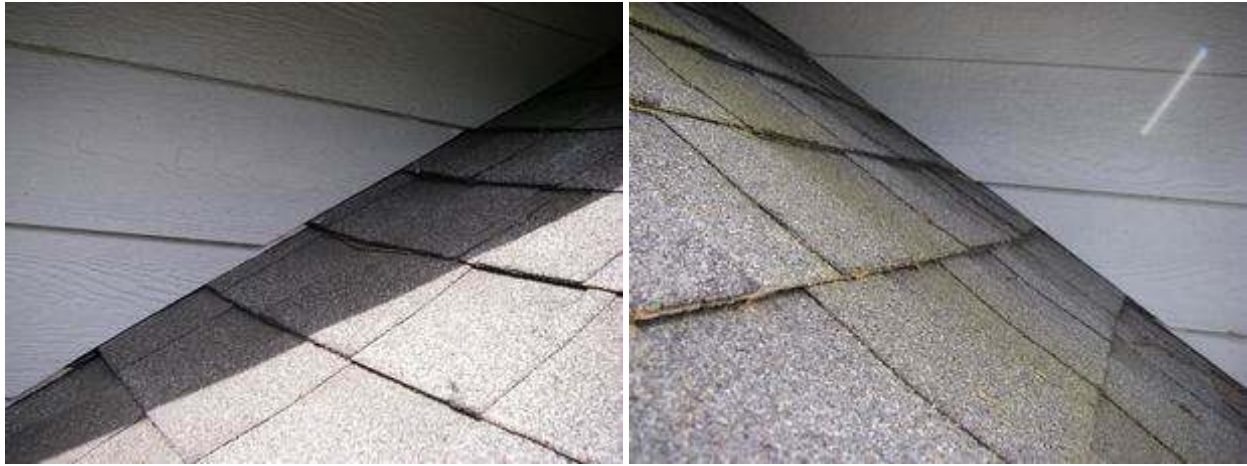
**Examples of improper siding installation on this home include inadequate clearances between siding and roof surface, thin or no paint on the drip edges, thin or no paint on field cut edges, impact damaged siding not replaced, butt joints not level and not caulked.** Each defect could, at the discretion of the manufacturer, void the warranty. *The siding installation should be corrected under the guidance of a manufacturer's representative to conform with the manufacturer's installation instructions to ensure that the manufacturer's*

11  
12 *siding touching roofing (should be a two inch gap)*

1 *warranty will be in force, or a manufacturer's representative should further evaluate the*  
2 *installation to confirm that the installation meets warranty requirements. In addition,*  
3 *requesting copies of the owner's maintenance and contractor's installation instructions is*  
4 *also highly recommended.*

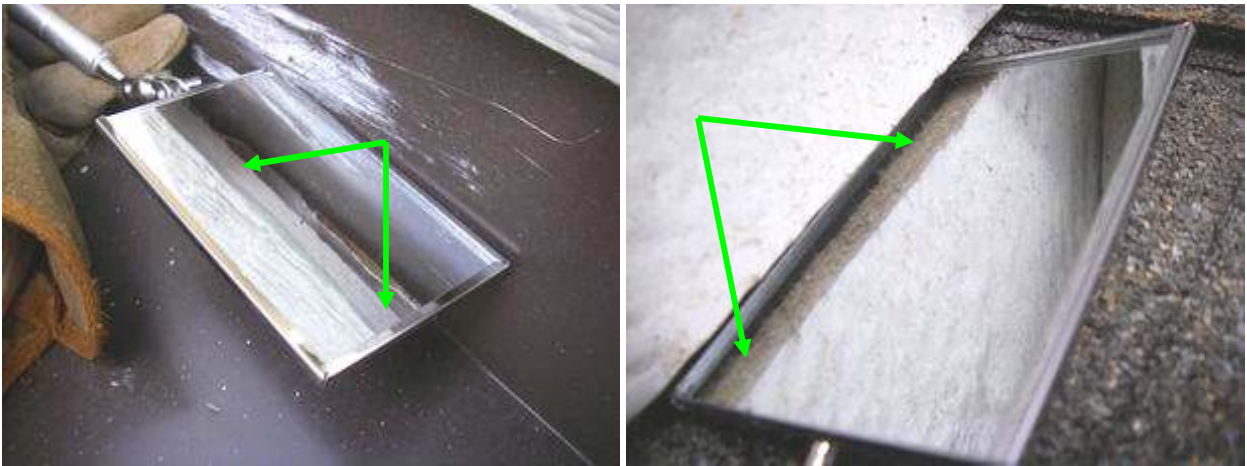
14  
15 *no field-applied paint at drip edge (primer visible) and bare wood visible at field cut*

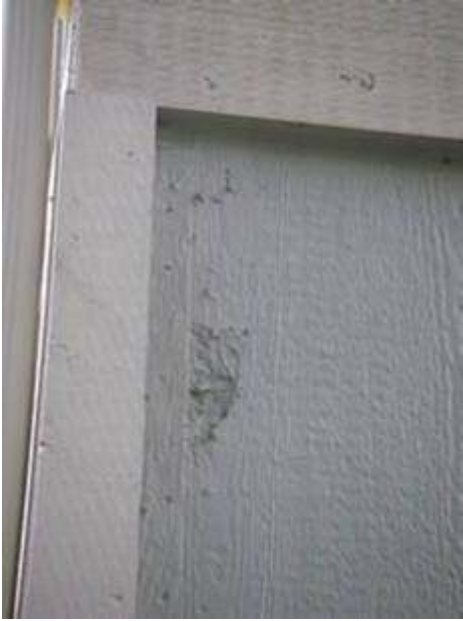
*damaged siding skin*

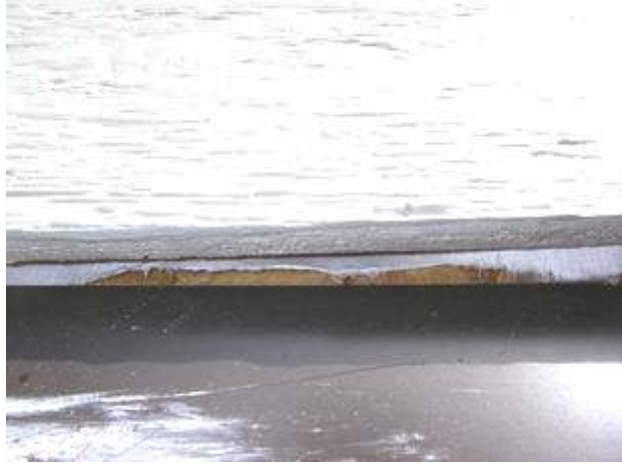
5  
6 **Of equal concern is that at the front of the dormer, the siding does not come down**  
7 **far enough and has left the sheathing exposed, and the requisite vapor barrier (paper or**  
8 **wrap) is not visible. It is somewhat worrisome that at the only area visible that should**  
9 **reveal paper, none exists.**

*exposed sheathing above roof-to-wall flashing*

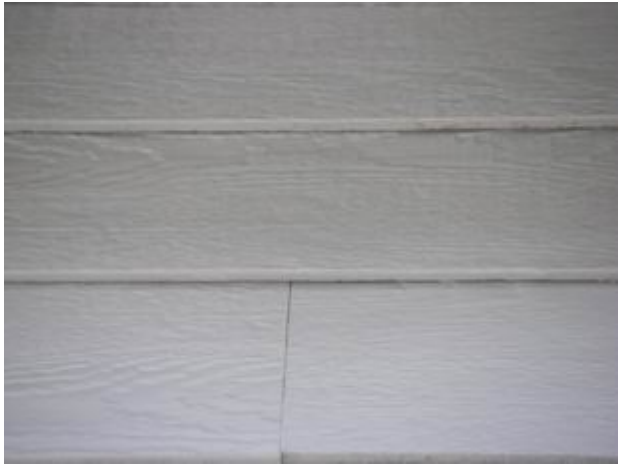
*butt joint uneven & not caulked*

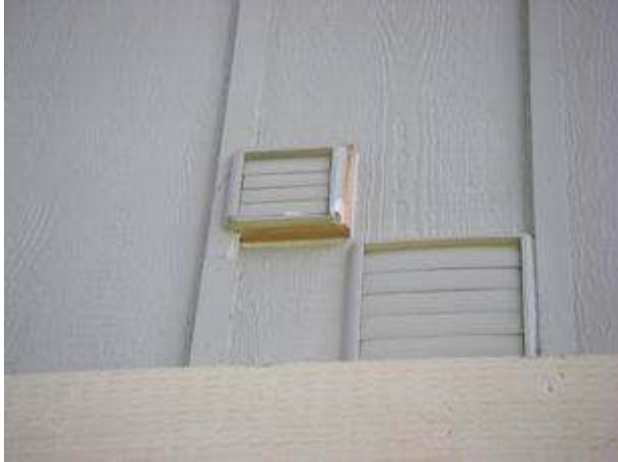
The door and window sills are in serviceable condition. The exterior hose bibs are functional and securely mounted to the home. **Some of the trim at a fan discharge remains unpainted. The soffit has been left off the bottom of the fireplace bump-out, leaving the framing and insulation exposed.** The eave areas are in serviceable condition with numerous vents to the attic.

*unpainted trim*

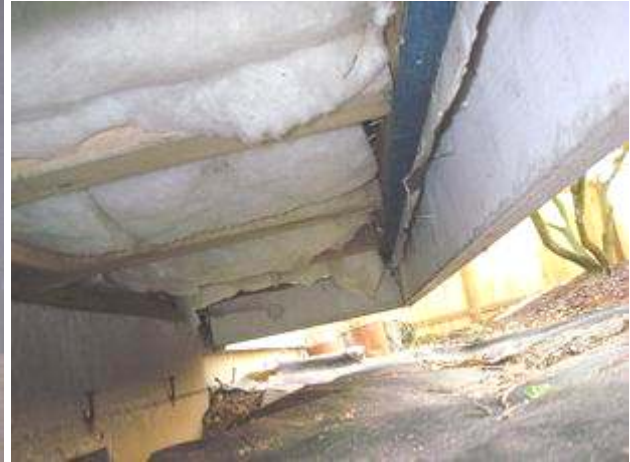
*missing soffit*

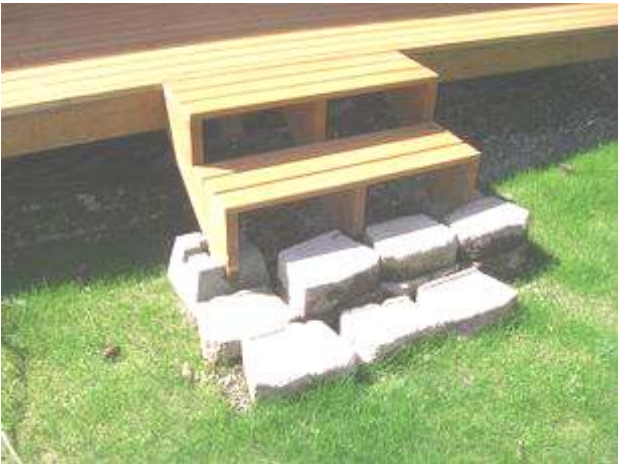
**The planks at the front entry deck are not adequately screwed down.** The rear deck is constructed with 1x4 decking and 2x6 joists 16 inches on center supported in turn by 4x6 beams mounted on 4x4 posts and pier blocks. **The steps for the deck are substandard, unprofessional, and hazardous.** **In addition, a handrail is required for stairs with four risers.**

*substandard deck steps*

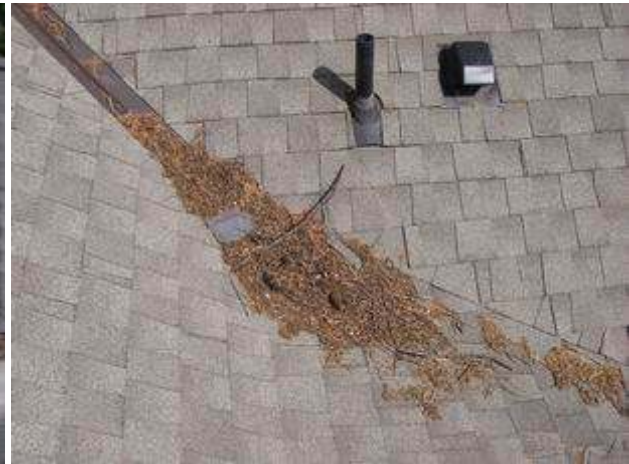
1 The roof consists of one tier of laminated architectural-style asphalt/fiberglass composition  
2 shingles. No significant defects were noted in the roofing material or valley or vertical plane  
3 flashing. **A considerable amount of construction debris has been left on the roof; the debris**  
4 **should be picked off the roof and out of the gutters to prevent it from entering the**  
5 **downspouts and drain lines. Any cellulose debris accumulation should also be removed from**  
6 **the roof surfaces and gutters.**  
7

***organic and construction debris***

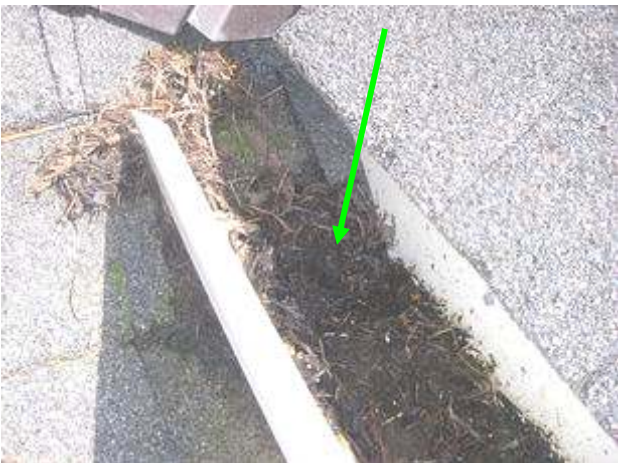
17  
18 ***enlarge opening here for better drainage***

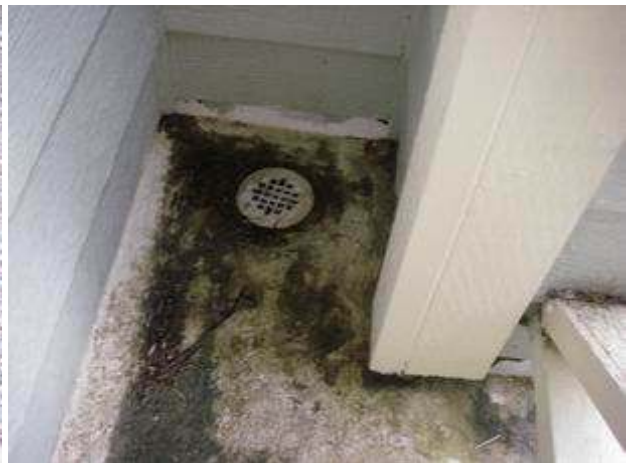
***drain grate over entry (see below)***

1 Due to what appears to be a sprayed-on finish, the type of roofing over the entry  
2 could not be determined. The grate for the drainage scupper is resting on the surface, so  
3 ponded water will accumulate on this surface. A conversation with the builder on this point  
4 is recommended.  
5  
6

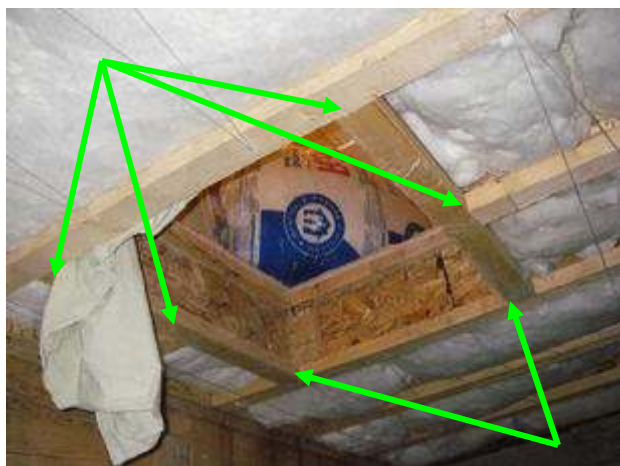
9 The crawl space is accessed via a pass-through in the understair closet. No significant  
10 defects were observed in the concrete perimeter footings, strip footings, or foundation walls. The  
11 foundation framing consists of 9½-inch Louisiana Pacific thin-web floor joist 16 inches on center  
12 mounted on 4x10 beams supported in turn by 4x4 posts. The header installed at the access and  
13 carrying one joist has been improperly nailed into place. Nailing through the chords is  
14 prohibited; hangers should have been used (as they were at the fireplace bump-out). The  
15 top chord of another joist has been notched for plumbing clearances, another prohibited  
16 modification. All manufactured joist companies dictate that their products not be modified  
17 in either of these ways and if they are, that the manufacturer must be contacted to design the  
18 appropriate repair to keep the warrant in force.

20 *joist hangers & nailers required at these points*

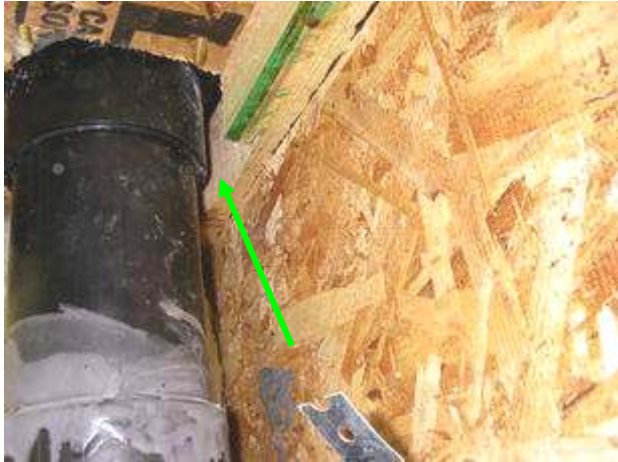
*notched top chord*

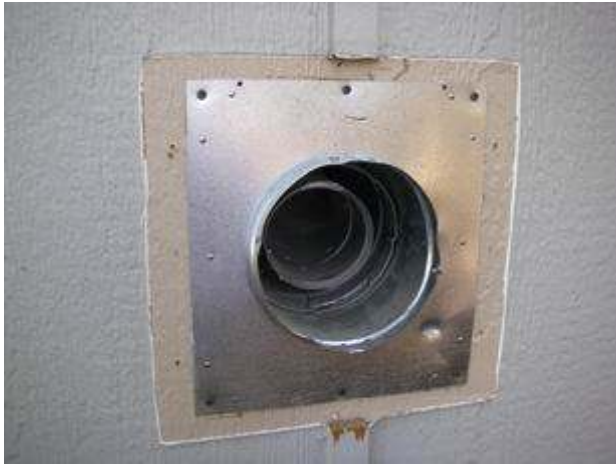
7 **The sealed gas fireplace is not yet fired, possibly because the exterior flue cap is**  
8 **missing. The purpose of the stubbed off gas line next to the fireplace is unknown but if it is**  
9 **not needed it should be properly terminated and the wall returned to a finish condition.**  
10

11 *missing cap at fireplace*

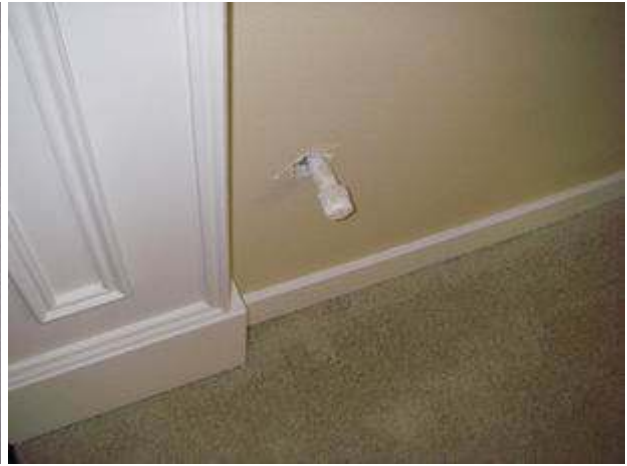
12 *gas line stub-out*

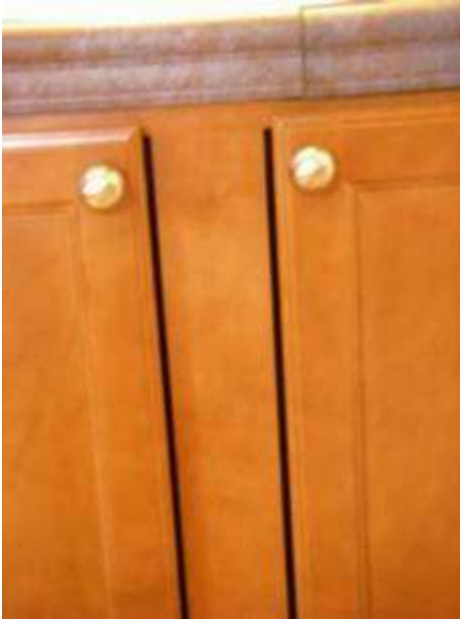
34 The dual vitreous china sinks, tile vanity top, and faucets are in serviceable condition. **The**  
35 **cabinet doors are not properly installed; a gap is visible when the right side doors are closed.**  
36 There are no noticeable leaks in the faucets, the P-trap drain assemblies, or the water supply lines.  
37

*misaligned cabinet doors*

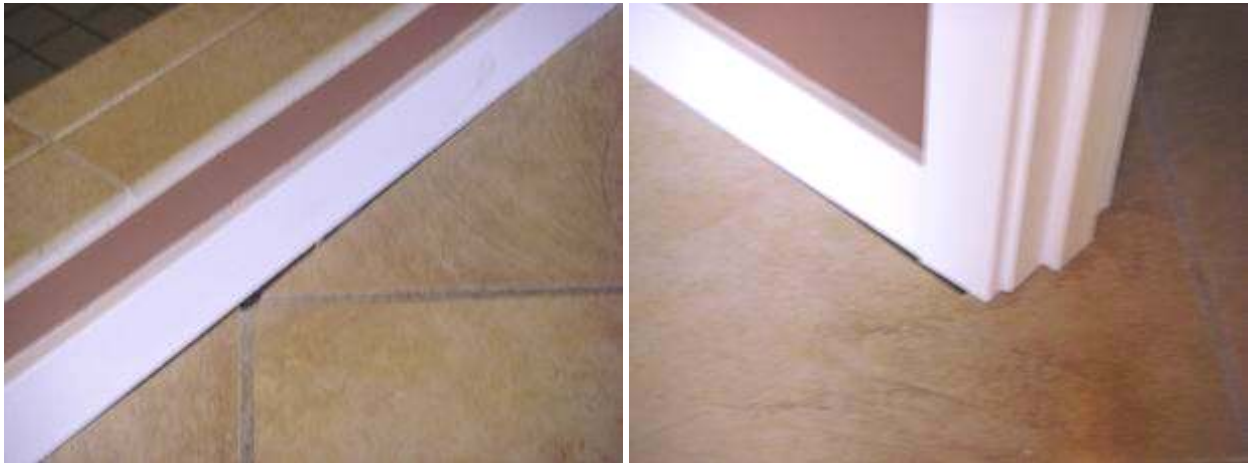
38 The 1.6 gallon commode functions properly and is solidly mounted. Water volume (flow)  
39 is adequate when two fixtures are used simultaneously. Moisture readings in the flooring at the  
40 bathtub, shower and commode were normal. **The tile flooring is mis-cut in at least two places**  
41 **with exposed edges.**

*gaps in tile flooring visible here*

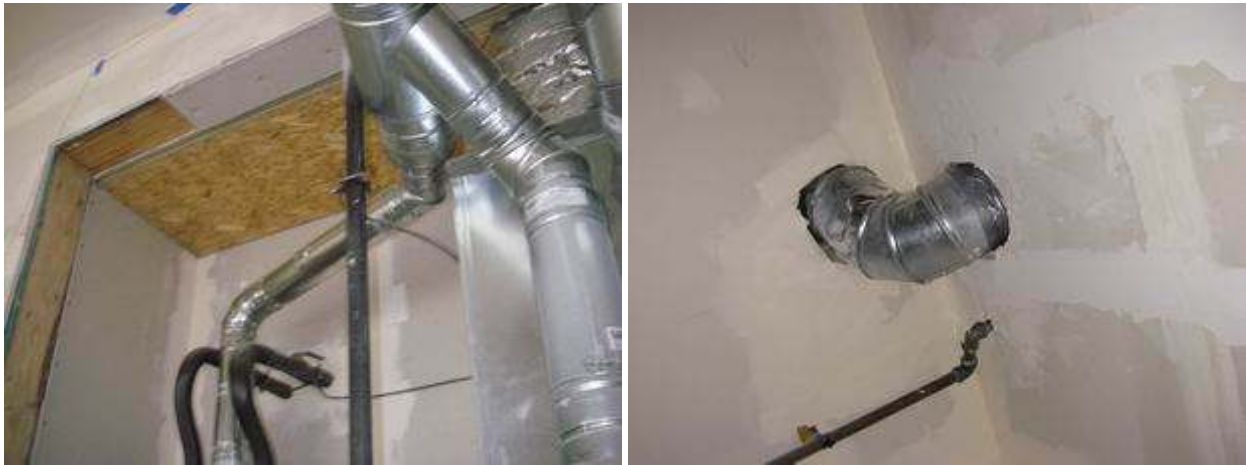
18  
19 The concrete slab floor is in serviceable condition, with normal settling cracks. **The wall**  
20 **and ceiling work for the fire-rated separation between the garage and living areas is**  
21 **incomplete.**  
22

23  
24 *integrity of fire-rating must be improved*  
25
