GENERAL BUILDING INSPECTION REPORT FOR
1111 11th Avenue, Seattle, Wa.
FOR THE EXCLUSIVE USE OF New Construction

May 2, 2000

cover letter, 24 page report

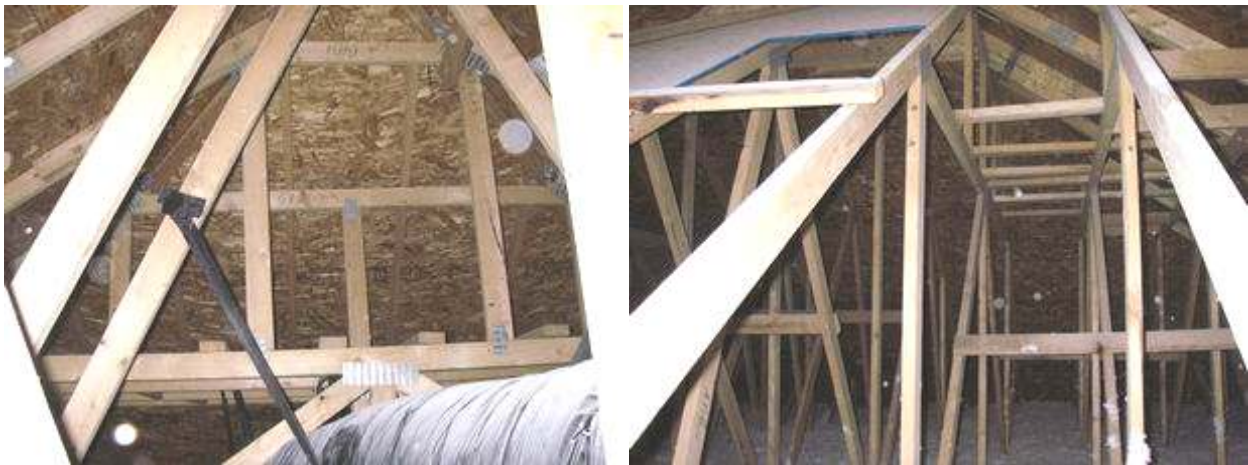
10
11 The roof framing consists of truss construction of a 2x4 configuration 24 inches on center
12 with 2x6 and 2x8 rafters in the transition areas. The oriented strandboard sheathing appears to be
13 in serviceable condition.
14

15
16 *roof framing, typical*
17

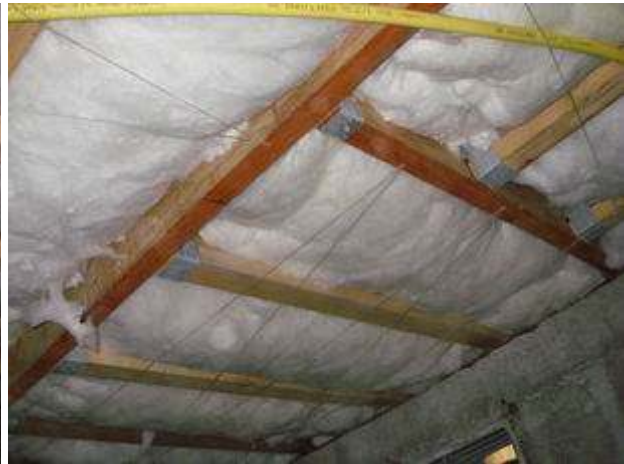
21 *properly installed hangers at fireplace*
