GENERAL BUILDING INSPECTION REPORT FOR
22716 Second Court of Last Resort, Spendy Suburb, Wa.
FOR THE EXCLUSIVE USE OF Savvy and Prudent Byers

Antiquarius 3, 2008

1 **OVERVIEW**

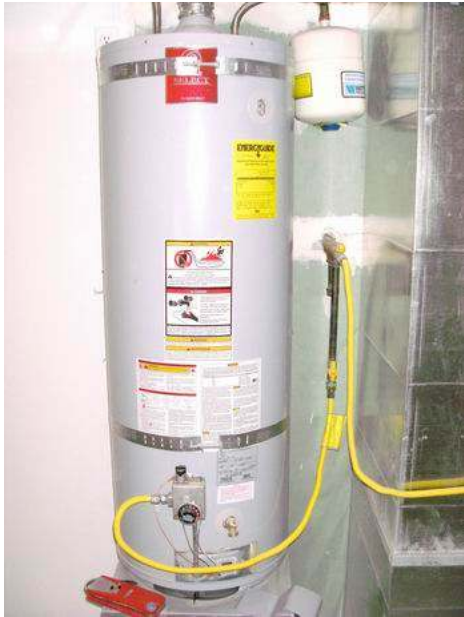
27
28 The water heater is equipped with a temperature/pressure relief (TPR) valve. The
29 temperature/pressure relief valve is set to open at either 150 psi or 210 degrees F. **There is no**
30 **discharge pipe installed at the pressure relief valve; discharge piping is required and should**
31 **discharge to the exterior of the house.** Earthquake restraining straps are in place. Observation
32 through the viewing port revealed a strong blue flame which is a sign of proper burning. Using the
33 TIF 8800 combustible gas detector, the gas supply lines were checked for natural gas leaks and
34 none were found. The ignition source is properly located a minimum of 18 inches above the
35 garage slab floor. No backdrafting or spillage was detected at the flue and no significant moisture
36 or corrosion was noted at the bottom of the water heater tank. **The exhaust flue for this**
37 **appliance has a significant reverse slope at two different places; gas flues must have 1/4-inch**

xx water heater

38 **per foot upward slope away from the appliance.** **A written dialogue with the local permitting**
39 **authority on this point is recommended.**

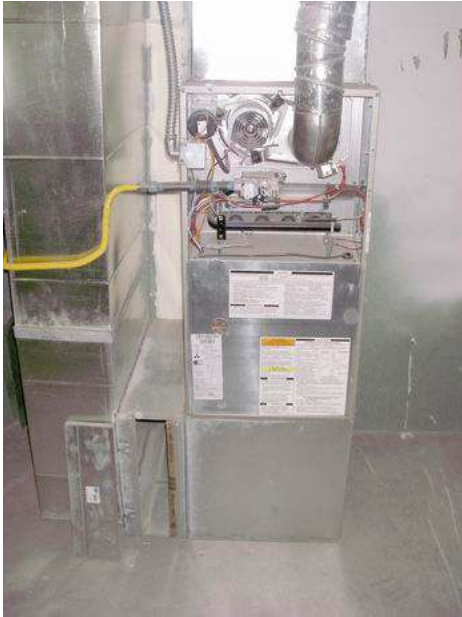
9
10 *Payne/Carrier gas-fired furnace*

13 This home is heated by an induced-draft Payne/Carrier gas-fired, four burner, 88,000
14 BTU updraft furnace with a hot surface igniter and a direct drive forced air distribution system
15 that is controlled by a RiteTemp thermostat. The thermostat is a set-back unit; it can be
16 programmed to reduce heat demand at off-peak hours, thereby reducing heating bills. **The**
17 **thermostat summer fan switch is not functional.**

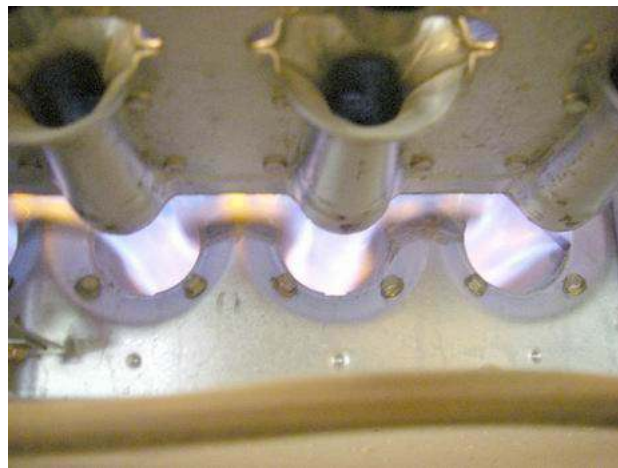
11
12 *strong blue flame*

18 Removal of the furnace panel cover revealed a strong blue flame and good flame
19 characteristics. Due to the design, none of the heat exchanger is accessible to inspection without
20 dismantling the furnace. The ignition source is located a minimum of 18 inches above the
21 garage slab floor. An impact barrier has been installed to prevent auto damage to the gas line.
22

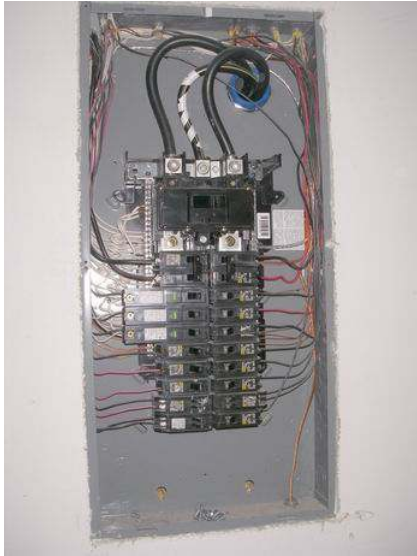
9 *Square D circuit breaker panel*

19 **Inspection of the wiring and circuit breaker panel reveal significant deficiencies that**
20 **include, but may not be limited to:**

- 21 • **no electrical permits found on site;**
22 • **defective AFCI breaker;**
23 • **no (dedicated) GFCI protection for the hydro-massage tub;**
24 • **receptacle with reversed polarity.**
25

26 **Due to the defects noted, a licensed electrician should be retained to survey this**
27 **system and make the necessary corrections.**

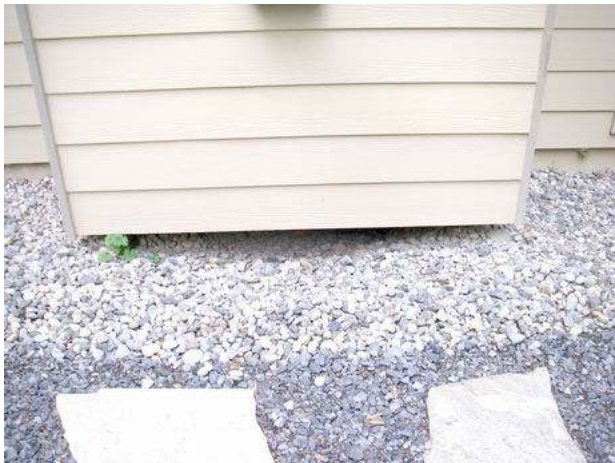
16
17 *fireplace bump-out*

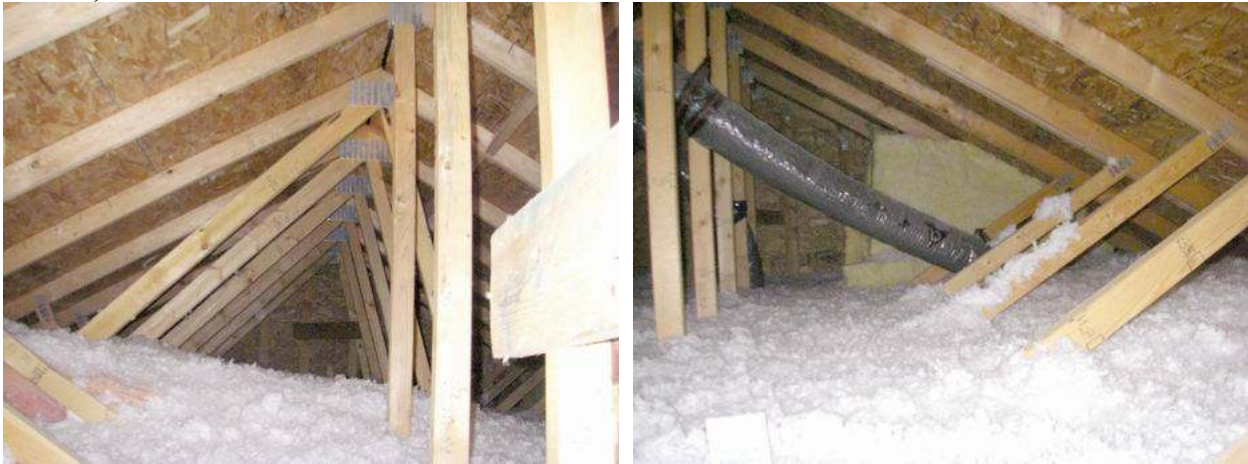
5
6 **Ventilation is substandard.** At least three of the holes cut through the sheathing have
7 been roofed over, and the installed roof ventilation does not meet the requirements (ten vents
8 for top roof, one each for main & entry roofs). At a minimum, attic ventilation should meet
9 the requirements documented in the prints. The air is currently dry and there are no signs of
10 condensation. The bathroom and laundry fans are ducted to the outside via roof vents (see ROOF
11 section).

12
13 *roof framing, typical*

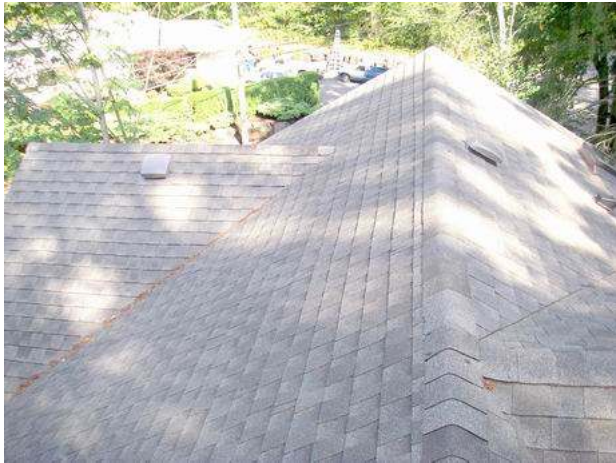
1 The roof consists of one tier of laminated architectural-style asphalt/fiberglass composition
2 shingles with wrapped valleys; metal roofing has been used on some of the smaller roof planes.
3 No significant defects were noted in the roofing material **but there are concerns over the roof**
4 **installation. All of the discharge vents for the various fan ducts have been sealed in place**
5 **with caulk - an unnecessary step if properly installed. None of the other roof penetrations**
6 **are so sealed, so the caulked units were likely retrofitted after the roof was installed.** Caulk is
7 a temporary and high-maintenance-owner-chore, and has no place on a new roof. **The**
8 **flashing at the skylights has not been properly installed, and neither the shingle tabs nor**
9 **flashing were extended down to protect the top of the barge rafters, so they will eventually**
10 **decay from exposure to the elements.** There are beginning accumulations of moss on the

11 southeast field that will eventually lift the shingle corners, making them susceptible to wind
12 lift, so all of the moss should be removed.
13

14 *laminated architectural-style shingle roof*

10
11 **Due to the deficiencies noted, *an independent licensed roofing contractor* – other than**
12 **the one that installed the roof - should be retained to further evaluate all of the roof, roof**
13 **systems and flashings and implement the necessary corrections.**

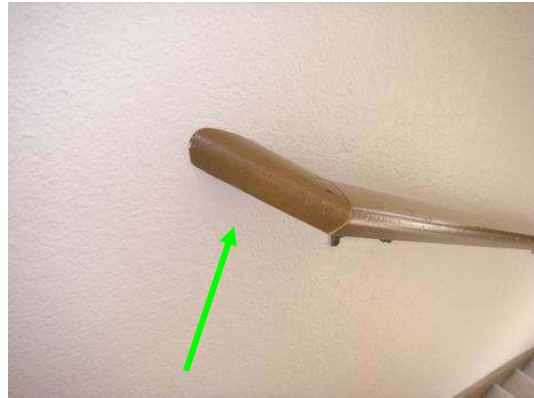
14
15 *typical handrail with proper "return"*

16 **The handrail in the stairwell to the garage is substandard in that the ends of the**
17 **handrail do not "return" to the wall.** Some of the walls and concrete slab floor are
18 **obstructed with stored material and could not be inspected.** The visible portion of the floor is
19 **in serviceable condition, with normal settling cracks.** **The access door to the crawl space should**
20 **be a solid-core fire-rated door to maintain the proper fire-rating between the garage and the**
21 **rest of the house.**
