**GENERAL BUILDING INSPECTION REPORT FOR**  
**1111 11th Avenue, Seattle, Wa.**  
**FOR THE EXCLUSIVE USE OF New Construction**

May 2, 2000

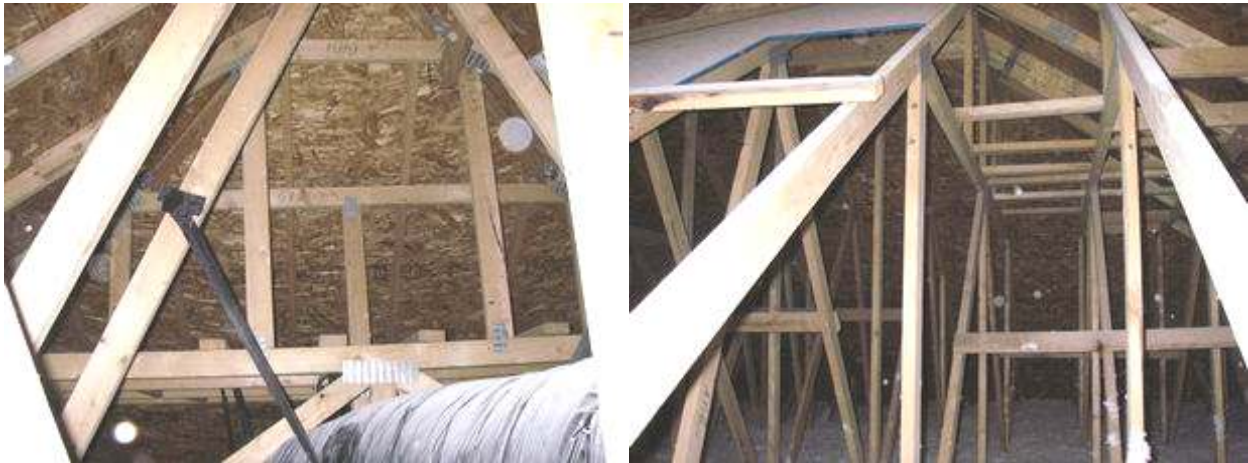
10  
11 The roof framing consists of truss construction of a 2x4 configuration 24 inches on center  
12 with 2x6 and 2x8 rafters in the transition areas. The oriented strandboard sheathing appears to be  
13 in serviceable condition.

15  
16 *roof framing, typical*

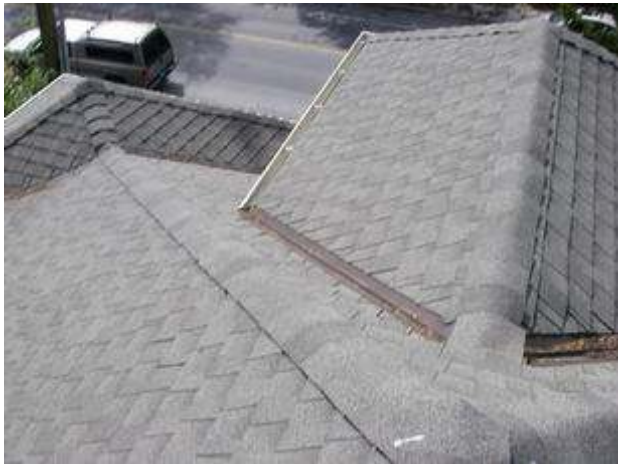
1 The roof consists of one tier of laminated architectural-style asphalt/fiberglass composition  
2 shingles. No significant defects were noted in the roofing material or valley or vertical plane  
3 flashing. **A considerable amount of construction debris has been left on the roof; the debris**  
4 **should be picked off the roof and out of the gutters to prevent it from entering the**  
5 **downspouts and drain lines. Any cellulose debris accumulation should also be removed from**  
6 **the roof surfaces and gutters.**  
7

8  
9 ***laminated architectural-style composition roof***

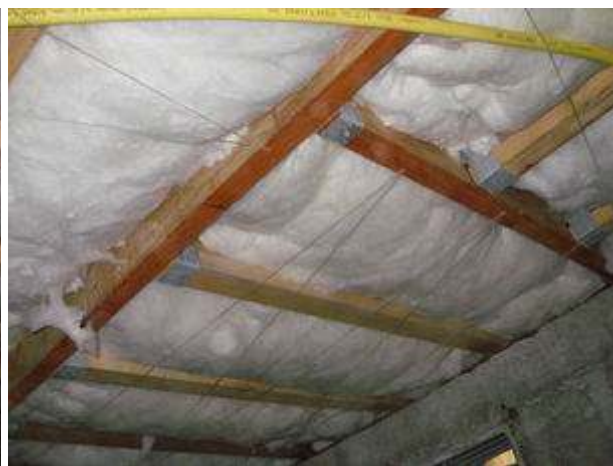
21 *properly installed hangers at fireplace*
